# Access Compliance Report

## Public Rights-of-Way

### (Curb Ramps)

Intersection ID: 48503	Main Street: KELBURN_LN	Cross Street: CASTLECOVE_RD	Location: SE
ADA ID: C715DBD355C2	Ramp Type: Para	Initial Pass/Fail: Fail	Overall Compliance: No
Severity Score: 12.5			
Codes/Mitigation Info/Possible Solution		Field Measurements/Component Compliance

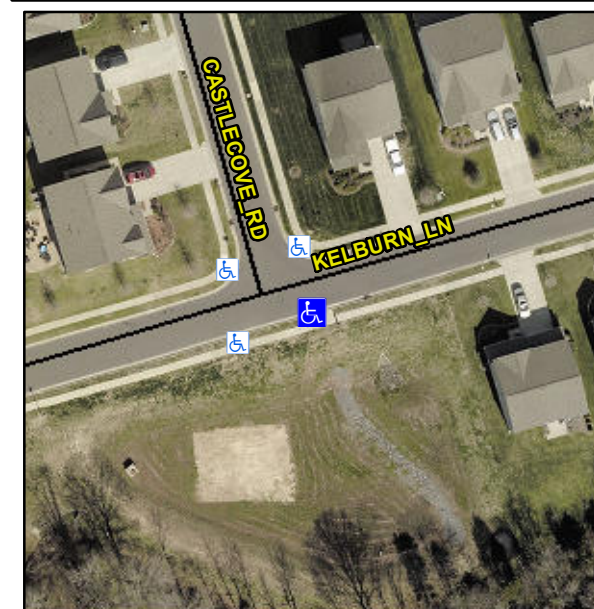
Compliance	Description	Data	Compliance	Description	Data
N/A	Ramp Length LT (in)	74.0	N/A	Ramp Length RT (in)	79.0
Yes	Ramp Width LT (in)	96.0	Yes	Ramp Width RT (in)	96.0
No	Ramp Slope LT (%)	10.2	Yes	Ramp Slope RT (%)	5.2
Yes	Ramp XSlope LT (%)	0.5	Yes	Ramp XSlope RT (%)	1.3
N/A	Landing Length (in)	N/A	N/A	DWS Provided?	N/A
N/A	Landing Width (in)	N/A	N/A	DWS Contrast?	N/A
N/A	Landing Slope (%)	N/A	N/A	DWS Length (in)	N/A
N/A	Landing X Slope (%)	N/A	N/A	DWS Full Width?	N/A
N/A	Landing Curb? (Y/N)	N/A	N/A	DWS Offset (in)	N/A
N/A	Shared Landing?	N/A			
N/A	Gutter Ponding?	N/A	N/A	Gutter Slope (%)	N/A
N/A	Gutter Lip Ht (in)	N/A	N/A	Gutter X Slope (%)	N/A
N/A	Painted X Walk1?	No	N/A	Painted X Walk2?	N/A
	X Walk 1 Direction	To NW		X Walk 2 Direction	N/A
N/A	X Walk 1 Width (in)	N/A	N/A	X Walk 2 Width (in)	N/A
	X Walk 1 Slope (%)	0.9		X Walk 2 Slope (%)	N/A
	X Walk 1 X Slope (%)	2.7		X Walk 2 X Slope (%)	N/A
N/A	Ramp inside XWalk1?	N/A	N/A	Ramp inside XWalk2?	N/A

Road Slope (%)	N/A	N/A	Clear Space?	N/A
	Road X Slope (%)	N/A	N/A	Clear Space to XWalk (in)	N/A
N/A	Any Obstructions?	N/A	N/A	Storm Grate/Utility Hazard?	N/A
	Obstruction Type			Storm Grate/Utility Type	
		N/A			N/A
			Yes	Surface Condition? (G/P)	Good
			N/A	Curb Slope (%)	7.3

Possible Solutions:

**Remove & Replace Entire Ramp.**

**R304.3.2**
