# Access Compliance Report

## Public Rights-of-Way

### (Curb Ramps)

Intersection ID: 24566	Main Street: BARDSTOWN_RD	Cross Street: SPRINGS_FARM_LN	Location:	N
ADA ID: C71602BF2D91	Ramp Type: PerpDiag	Initial Pass/Fail: Fail	Overall Compliance: No	Severity Score: 25

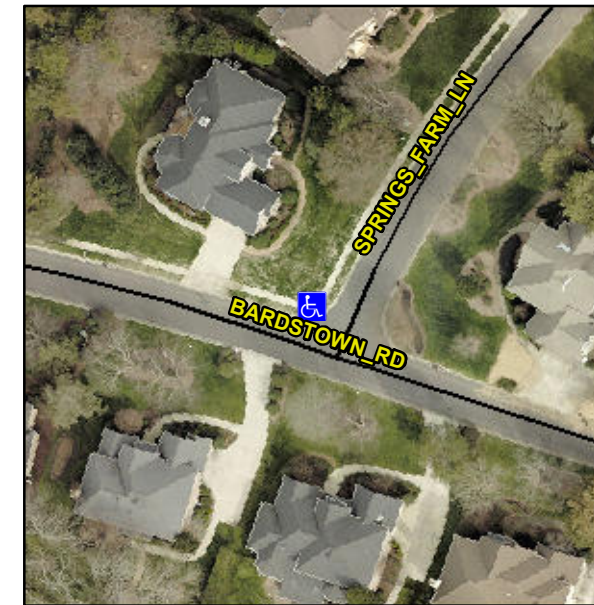
**Not Found, R304.5.3**

Compliance	Description	Data	Compliance	Description	Data
N/A	Ramp Length (in)	95.0	Yes	Ramp Slope (%)	5.8
Yes	Ramp Width (in)	48.0	No	Ramp XSlope (%)	8.6
N/A	Flare Type LT	N/A	N/A	Flare Type RT	N/A
N/A	Flare Slope LT (%)	N/A	N/A	Flare Slope RT (%)	N/A
N/A	Flare Traversable LT?	N/A	N/A	Flare Traversable RT?	N/A
N/A	Landing Length (in)	N/A	N/A	DWS Provided?	N/A
N/A	Landing Width (in)	N/A	N/A	DWS Contrast?	N/A
N/A	Landing Slope (%)	N/A	N/A	DWS Length (in)	N/A
N/A	Landing X Slope (%)	N/A	N/A	DWS Full Width?	N/A
N/A	Landing Curb? (Y/N)	N/A	N/A	DWS Offset (in)	N/A
N/A	Shared Landing?	N/A			
N/A	Gutter Ponding?	N/A	N/A	Gutter Slope (%)	N/A
N/A	Gutter Lip Ht (in)	N/A	N/A	Gutter X Slope (%)	N/A
N/A	Painted X Walk1?	No	N/A	Painted X Walk2?	No
	X Walk 1 Direction	To S		X Walk 2 Direction	To SE
N/A	X Walk 1 Width (in)	N/A	N/A	X Walk 2 Width (in)	N/A
	X Walk 1 Slope (%)	1.5		X Walk 2 Slope (%)	4.7
	X Walk 1 X Slope (%)	5.0		X Walk 2 X Slope (%)	0.1

N/A	Ramp inside XWalk1?	N/A	N/A	Ramp inside XWalk2?	N/A
	Road Slope (%)	5.2	N/A	Clear Space?	N/A
	Road X Slope (%)	6.0	N/A	Clear Space to XWalk (in)	N/A
N/A	Any Obstructions?	N/A	N/A	Storm Grate/Utility Hazard?	N/A
	Obstruction Type			Storm Grate/Utility Type	
		N/A			N/A
			Yes	Surface Condition? (G/P)	Good

**Remove & Replace Curb Ramp With Two New Directional Ramps or Equivalent.**

Total Cost: \$ 3200.00
