Access Compliance Report

Public Rights-of-Way

(Curb Ramps)

Intersection ID: 11316	Main Street: CAMP_GREENE_ST	Cross Street: ROYSTON_RD	Location: SW
ADA ID: C71B690576DE	Ramp Type: Perp	Initial Pass/Fail: Fail	Overall Compliance: No
Severity Score: 22.5			
Codes/Mitigation Info/Possible Solution		Field Measurements/Component Compliance

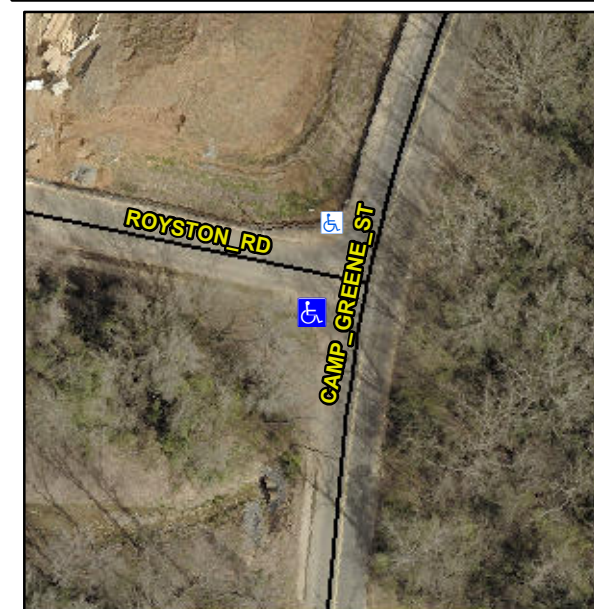
Not Found, R304.5.1, R304.2.2, R304.5.3

Compliance	Description	Data	Compliance	Description	Data
N/A	Ramp Length (in)	60.0	No	Ramp Slope (%)	9.3
No	Ramp Width (in)	39.0	No	Ramp XSlope (%)	4.3
N/A	Flare Type LT	N/A	N/A	Flare Type RT	N/A
N/A	Flare Slope LT (%)	N/A	N/A	Flare Slope RT (%)	N/A
N/A	Flare Traversable LT?	N/A	N/A	Flare Traversable RT?	N/A
N/A	Landing Length (in)	N/A	N/A	DWS Provided?	N/A
N/A	Landing Width (in)	N/A	N/A	DWS Contrast?	N/A
N/A	Landing Slope (%)	N/A	N/A	DWS Length (in)	N/A
N/A	Landing X Slope (%)	N/A	N/A	DWS Full Width?	N/A
N/A	Landing Curb? (Y/N)	N/A	N/A	DWS Offset (in)	N/A
N/A	Shared Landing?	N/A			
N/A	Gutter Ponding?	N/A	N/A	Gutter Slope (%)	N/A
N/A	Gutter Lip Ht (in)	N/A	N/A	Gutter X Slope (%)	N/A
N/A	Painted X Walk1?	No	N/A	Painted X Walk2?	N/A
	X Walk 1 Direction	To N		X Walk 2 Direction	N/A
N/A	X Walk 1 Width (in)	N/A	N/A	X Walk 2 Width (in)	N/A
	X Walk 1 Slope (%)	3.0		X Walk 2 Slope (%)	N/A
	X Walk 1 X Slope (%)	2.7		X Walk 2 X Slope (%)	N/A

Remove & Replace Entire Ramp.

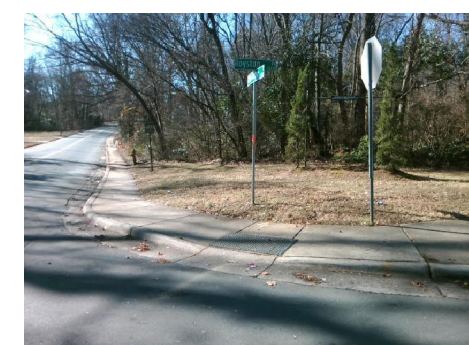
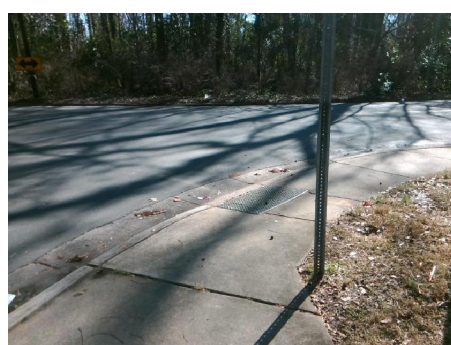
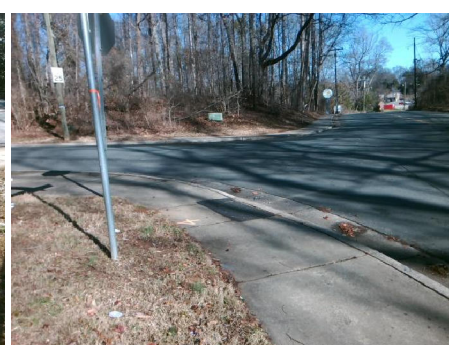
N/A	Ramp inside XWalk1?	N/A	N/A	Ramp inside XWalk2?	N/A
	Road Slope (%)	N/A	N/A	Clear Space?	N/A
	Road X Slope (%)	N/A	N/A	Clear Space to XWalk (in)	N/A
N/A	Any Obstructions?	N/A	N/A	Storm Grate/Utility Hazard?	N/A
	Obstruction Type			Storm Grate/Utility Type	
		N/A			N/A
			Yes	Surface Condition? (G/P)	Good
