# Access Compliance Report

## Public Rights-of-Way

### (Curb Ramps)

Intersection ID: 16168	Main Street: CORONADO_DR	Cross Street: FARMINGDALE_DR	Location:	N
ADA ID: C724870CC067	Ramp Type: PerpDiag	Initial Pass/Fail: Fail	Overall Compliance: No	Severity Score: 10

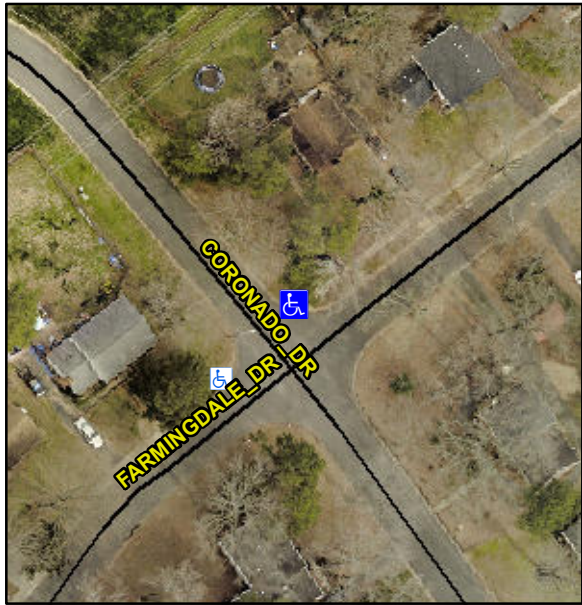
Possible Solutions:		Compliance	Description	Data	Compliance	Description	Data
	<b>Remove &amp; Replace Curb Ramp With Two New Directional Ramps or Equivalent.</b>		N/A	Ramp Length (in)	48.0	Yes	Ramp Slope (%)	5.7
			No	Ramp Width (in)	47.0	No	Ramp XSlope (%)	3.7
			N/A	Flare Type LT	N/A	N/A	Flare Type RT	N/A
			N/A	Flare Slope LT (%)	N/A	N/A	Flare Slope RT (%)	N/A
			N/A	Flare Traversable LT?	N/A	N/A	Flare Traversable RT?	N/A
			N/A	Landing Length (in)	N/A	N/A	DWS Provided?	N/A
			N/A	Landing Width (in)	N/A	N/A	DWS Contrast?	N/A
			N/A	Landing Slope (%)	N/A	N/A	DWS Length (in)	N/A
			N/A	Landing X Slope (%)	N/A	N/A	DWS Full Width?	N/A
Surveyor Notes:	N/A		N/A	Landing Curb? (Y/N)	N/A	N/A	DWS Offset (in)	N/A
			N/A	Shared Landing?	N/A			
			N/A	Gutter Ponding?	N/A	N/A	Gutter Slope (%)	N/A
			N/A	Gutter Lip Ht (in)	N/A	N/A	Gutter X Slope (%)	N/A

N/A	Painted X Walk1?	No	N/A	Painted X Walk2?	No
				X Walk 1 Direction	To SW		X Walk 2 Direction	To SE
			N/A	X Walk 1 Width (in)	N/A	N/A	X Walk 2 Width (in)	N/A
				X Walk 1 Slope (%)	1.6		X Walk 2 Slope (%)	4.3
				X Walk 1 X Slope (%)	3.4		X Walk 2 X Slope (%)	1.2
			N/A	Ramp inside XWalk1?	N/A	N/A	Ramp inside XWalk2?	N/A
PROW/ADA:	<b>Not Found, R304.5.1, R304.5.3</b>			Road Slope (%)	1.4	N/A	Clear Space?	N/A
				Road X Slope (%)	4.8	N/A	Clear Space to XWalk (in)	N/A
			N/A	Any Obstructions?	N/A	N/A	Storm Grate/Utility Hazard?	N/A
				Obstruction Type			Storm Grate/Utility Type	
					N/A			N/A
						Yes	Surface Condition? (G/P)	Good
Total Cost:		\$ 3200.00
