Access Compliance Report

Public Rights-of-Way

(Curb Ramps)

Intersection ID: 10025452	Main Street: E_INDEPENDENCE_BV	Cross Street: N/A	Location: SW
ADA ID: C72DFA03E769	Ramp Type: Directional1	Initial Pass/Fail: Pass	Overall Compliance: No
		Severity Score: 0

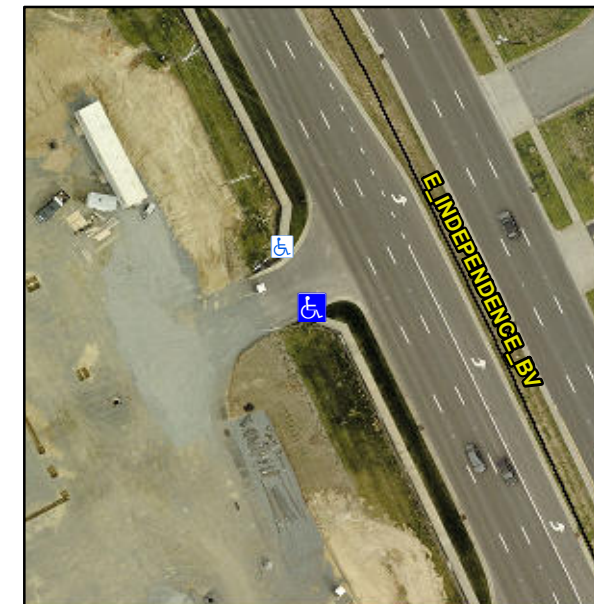
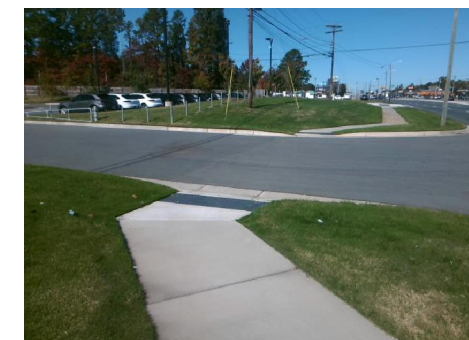
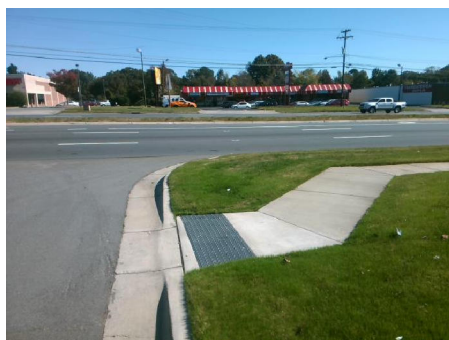
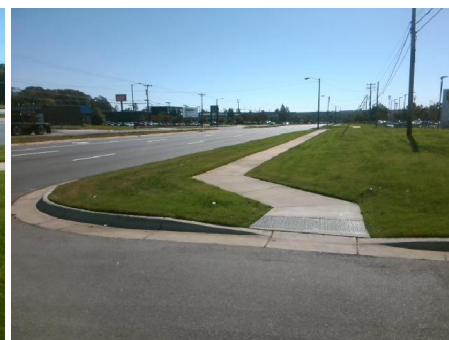
Not Found, R304.5.3, R305.2

Compliance	Description	Data	Compliance	Description	Data
N/A	Ramp Length (in)	45.0	Yes	Grade Break?	Yes
Yes	Ramp Width (in)	61.0	No	Grade Break Slope (%)	13.7
Yes	Ramp Slope (%)	4.5	Yes	Grade Break XSlope (%)	0.1
Yes	Ramp XSlope (%)	1.5			
N/A	Flare Type LT	N/A	N/A	Flare Type RT	N/A
N/A	Flare Slope LT (%)	N/A	N/A	Flare Slope RT (%)	N/A
N/A	Flare Traversable LT?	N/A	N/A	Flare Traversable RT?	N/A
Yes	Landing Length (in)	62.0	Yes	DWS Provided?	Yes
Yes	Landing Width (in)	59.0	Yes	DWS Contrast?	Yes
Yes	Landing Slope (%)	1.0	Yes	DWS Length (in)	24.0
Yes	Landing X Slope (%)	1.4	Yes	DWS Full Width?	Yes
N/A	Landing Curb? (Y/N)	No	No	DWS Offset LT (in)	2.5
N/A	Shared Landing?	No	Yes	DWS Offset RT (in)	6.0
Yes	Gutter Ponding?	No	Yes	Gutter Slope (%)	1.1
Yes	Gutter Lip Ht (in)	0.0	Yes	Gutter X Slope (%)	1.4
N/A	Painted X Walk1?	No		Road Slope (%)	3.6
	X Walk 1 Direction	To NW		Road X Slope (%)	1.6
	X Walk 1 Width (in)	N/A		Clear Space?	Yes

X Walk 1 Slope (%)	3.6	N/A	Clear Space to XWalk (in)	N/A
	X Walk 1 X Slope (%)	1.6	Yes	Storm Grate/Utility Hazard?	No
N/A	Ramp inside XWalk1?	N/A		Storm Grate/Utility Type	
Yes	Any Obstructions?	No			N/A
	Obstruction Type		Yes	Surface Condition? (G/P)	Good
			N/A	Curb Slope (%)	14.3

Possible Solutions:

Remove & Replace Entire Ramp.

Total Cost: \$ 1600.00
