Access Compliance Report

Public Rights-of-Way (Curb Ramps)

Intersection ID: 53160	Main Street: PERTH_MOOR_RD	Cross Street: HAMILTON_BRIDGE_RD	Location: NW
ADA ID: C732707F46E2	Ramp Type: BlendTrans2	Initial Pass/Fail: Fail	Overall Compliance: No
Severity Score: 10

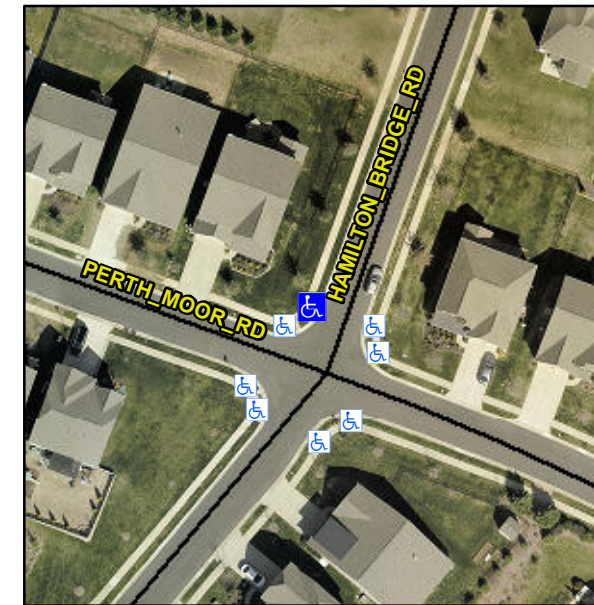
Compliance	Description	Data	Compliance	Description	Data
N/A	Ramp Length (in)	98.0	Yes	BlendTrans Slope (%)	0.0
No	Ramp Width (in)	42.0	Yes	BlendTrans XSlope (%)	4.3
N/A	Flare Type LT	N/A	N/A	Flare Type RT	N/A
N/A	Flare Slope LT (%)	N/A	N/A	Flare Slope RT (%)	N/A
N/A	Flare Traversable LT?	N/A	N/A	Flare Traversable RT?	N/A
N/A	Landing Length (in)	N/A	N/A	DWS Provided?	N/A
N/A	Landing Width (in)	N/A	N/A	DWS Contrast?	N/A
N/A	Landing Slope (%)	N/A	N/A	DWS Length (in)	N/A
N/A	Landing X Slope (%)	N/A	N/A	DWS Full Width?	N/A
N/A	Landing Curb? (Y/N)	N/A	N/A	DWS Offset (in)	N/A
N/A	Shared Landing?	N/A			
N/A	Gutter Ponding?	N/A	N/A	Gutter Slope (%)	N/A
N/A	Gutter Lip Ht (in)	1.5	N/A	Gutter X Slope (%)	N/A
N/A	Painted X Walk1?	No	N/A	Painted X Walk2?	N/A
	X Walk 1 Direction	To E		X Walk 2 Direction	N/A
	X Walk 1 Width (in)	N/A		X Walk 2 Width (in)	N/A
	X Walk 1 Slope (%)	1.9		X Walk 2 Slope (%)	N/A
	X Walk 1 X Slope (%)	5.3		X Walk 2 X Slope (%)	N/A

N/A	Ramp inside XWalk1?	N/A	N/A	Ramp inside XWalk2?	N/A
	Road Slope (%)	5.3		Clear Space?	N/A
	Road X Slope (%)	1.9	N/A	Clear Space to XWalk (in)	N/A
N/A	Any Obstructions?	N/A	N/A	Storm Grate/Utility Hazard?	N/A
	Obstruction Type			Storm Grate/Utility Type	
		N/A			N/A
			Yes	Surface Condition? (G/P)	Good
			N/A	Curb Slope (%)	4.1

Remove & Replace Curb Ramp With Two New Directional Ramps or Equivalent.

R304.5.1
