Access Compliance Report

Public Rights-of-Way

(Curb Ramps)

Intersection ID: 12365	Main Street: E_10TH_ST	Cross Street: N_ALEXANDER_ST	Location: N
ADA ID: C738D0489F06	Ramp Type: PerpDiag	Initial Pass/Fail: Fail	Overall Compliance: No
Severity Score: 13.75			
Codes/Mitigation Info/Possible Solution		Field Measurements/Component Compliance

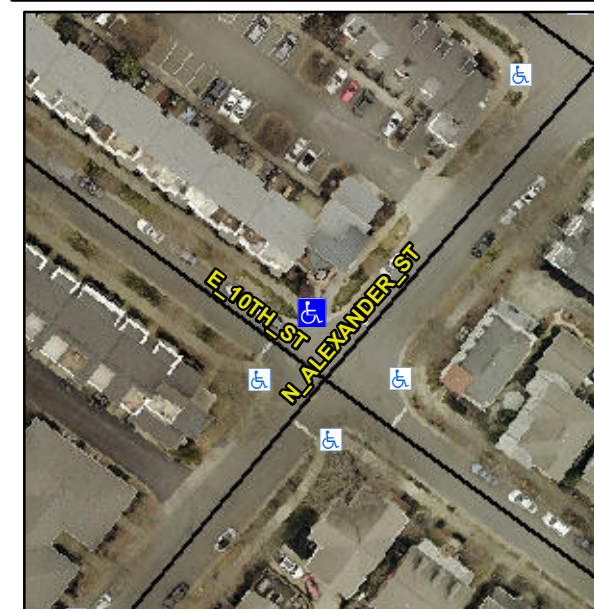
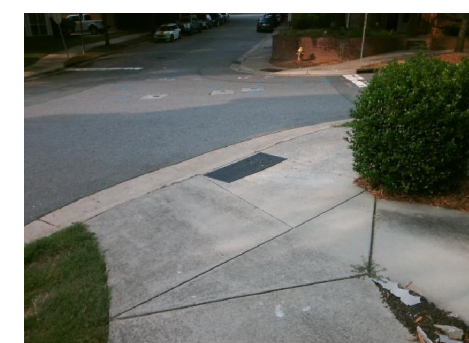
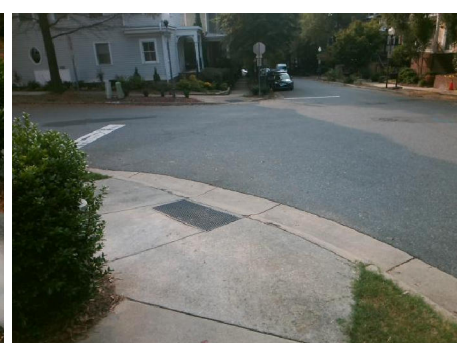
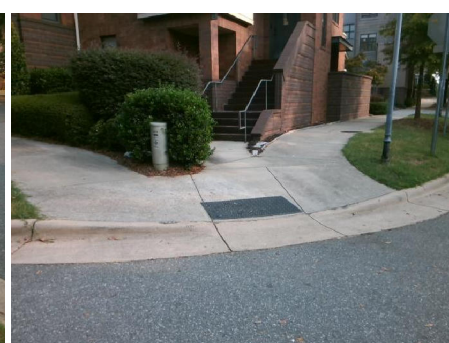
Not Found, R304.2.2, R304.5.3

Compliance	Description	Data	Compliance	Description	Data
N/A	Ramp Length (in)	86.0	No	Ramp Slope (%)	10.1
Yes	Ramp Width (in)	49.0	No	Ramp XSlope (%)	3.8
N/A	Flare Type LT	N/A	N/A	Flare Type RT	N/A
N/A	Flare Slope LT (%)	N/A	N/A	Flare Slope RT (%)	N/A
N/A	Flare Traversable LT?	N/A	N/A	Flare Traversable RT?	N/A
N/A	Landing Length (in)	N/A	N/A	DWS Provided?	N/A
N/A	Landing Width (in)	N/A	N/A	DWS Contrast?	N/A
N/A	Landing Slope (%)	N/A	N/A	DWS Length (in)	N/A
N/A	Landing X Slope (%)	N/A	N/A	DWS Full Width?	N/A
N/A	Landing Curb? (Y/N)	N/A	N/A	DWS Offset (in)	N/A
N/A	Shared Landing?	N/A			
N/A	Gutter Ponding?	N/A	N/A	Gutter Slope (%)	N/A
N/A	Gutter Lip Ht (in)	N/A	N/A	Gutter X Slope (%)	N/A
N/A	Painted X Walk1?	No	N/A	Painted X Walk2?	No
	X Walk 1 Direction	To SW		X Walk 2 Direction	To SE
N/A	X Walk 1 Width (in)	N/A	N/A	X Walk 2 Width (in)	N/A
	X Walk 1 Slope (%)	2.1		X Walk 2 Slope (%)	6.1
	X Walk 1 X Slope (%)	6.6		X Walk 2 X Slope (%)	0.2

N/A	Ramp inside XWalk1?	N/A	N/A	Ramp inside XWalk2?	N/A
	Road Slope (%)	3.1	N/A	Clear Space?	N/A
	Road X Slope (%)	5.8	N/A	Clear Space to XWalk (in)	N/A
N/A	Any Obstructions?	N/A	N/A	Storm Grate/Utility Hazard?	N/A
	Obstruction Type			Storm Grate/Utility Type	
		N/A			N/A
			Yes	Surface Condition? (G/P)	Good

Remove & Replace Curb Ramp With Two New Directional Ramps or Equivalent.
