# Access Compliance Report

## Public Rights-of-Way

### (Curb Ramps)

Intersection ID: 13898	Main Street: S_MINT_ST	Cross Street: WILMORE_DR	Location: NE
ADA ID: C73B2DC2D452	Ramp Type: PerpDiag	Initial Pass/Fail: Fail	Overall Compliance: No
		Severity Score: 50

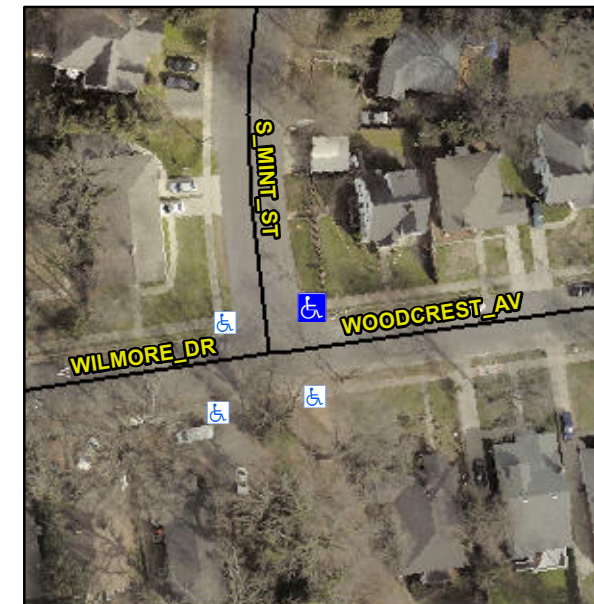
Compliance	Description	Data	Compliance	Description	Data
N/A	Ramp Length (in)	83.0	No	Ramp Slope (%)	17.4
Yes	Ramp Width (in)	48.0	No	Ramp XSlope (%)	8.9
N/A	Flare Type LT	N/A	N/A	Flare Type RT	N/A
N/A	Flare Slope LT (%)	N/A	N/A	Flare Slope RT (%)	N/A
N/A	Flare Traversable LT?	N/A	N/A	Flare Traversable RT?	N/A
N/A	Landing Length (in)	N/A	N/A	DWS Provided?	N/A
N/A	Landing Width (in)	N/A	N/A	DWS Contrast?	N/A
N/A	Landing Slope (%)	N/A	N/A	DWS Length (in)	N/A
N/A	Landing X Slope (%)	N/A	N/A	DWS Full Width?	N/A
N/A	Landing Curb? (Y/N)	N/A	N/A	DWS Offset (in)	N/A
N/A	Shared Landing?	N/A			
N/A	Gutter Ponding?	N/A	N/A	Gutter Slope (%)	N/A
N/A	Gutter Lip Ht (in)	N/A	N/A	Gutter X Slope (%)	N/A
N/A	Painted X Walk1?	No	N/A	Painted X Walk2?	No
	X Walk 1 Direction	To W		X Walk 2 Direction	To S
N/A	X Walk 1 Width (in)	N/A	N/A	X Walk 2 Width (in)	N/A
	X Walk 1 Slope (%)	1.6		X Walk 2 Slope (%)	2.5
	X Walk 1 X Slope (%)	4.7		X Walk 2 X Slope (%)	3.6

N/A	Ramp inside XWalk1?	N/A	N/A	Ramp inside XWalk2?	N/A
	Road Slope (%)	5.3	N/A	Clear Space?	N/A
	Road X Slope (%)	0.4	N/A	Clear Space to XWalk (in)	N/A
N/A	Any Obstructions?	N/A	N/A	Storm Grate/Utility Hazard?	N/A
	Obstruction Type			Storm Grate/Utility Type	
		N/A			N/A
		Yes		Surface Condition? (G/P)	Good

**Remove & Replace Curb Ramp With Two New Directional Ramps or Equivalent.**

**R304.2.2, R304.5.3**
