Access Compliance Report

Public Rights-of-Way

(Curb Ramps)

| Intersection ID: 50463 | Main Street: EVERTON_DR | Cross Street: LENOX_POINTE_DR | Location: SW |

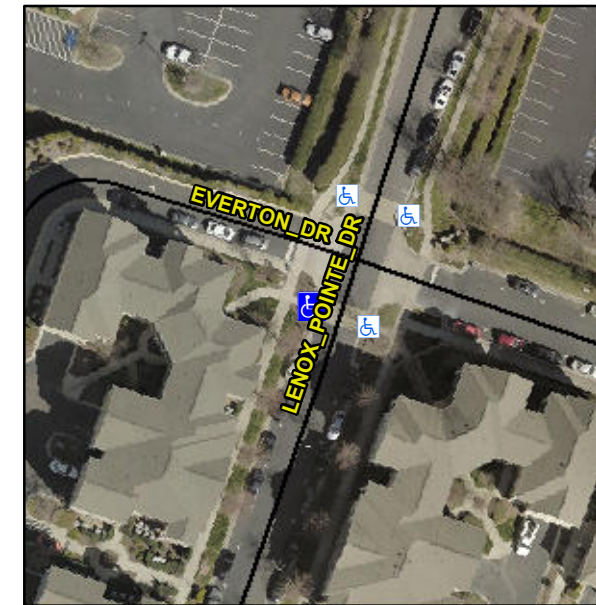
Not Found, R304.5.3, R304.2.2-Perp, R304.3.2-Para, R305.2

| Compliance | Description | Data | Compliance | Description | Data |
|---|---|---|---|---|---|
| Yes | Ramp Width (in) | 48.0 | No | Ramp XSlope (%) | 2.7 |
| No | Landing Slope (%) | 2.1 | Yes | DWS Length (in) | 24.0 |
| No | Landing X Slope (%) | 2.8 | Yes | DWS Full Width? | Yes |
| N/A | Landing Curb? (Y/N) | No | No | DWS Offset (in) | 5.0 |

Remove & Replace Entire Ramp.
