Access Compliance Report

Public Rights-of-Way

(Curb Ramps)

Intersection ID: 49144	Main Street: AMBER_LEIGH_WAY_DR	Cross Street: LOOKOUT_POINT_DR	Location: E
ADA ID: C73C0822180F	Ramp Type: Perp	Initial Pass/Fail: Fail	Overall Compliance: No
Severity Score: 22.5			
Codes/Mitigation Info/Possible Solution		Field Measurements/Component Compliance

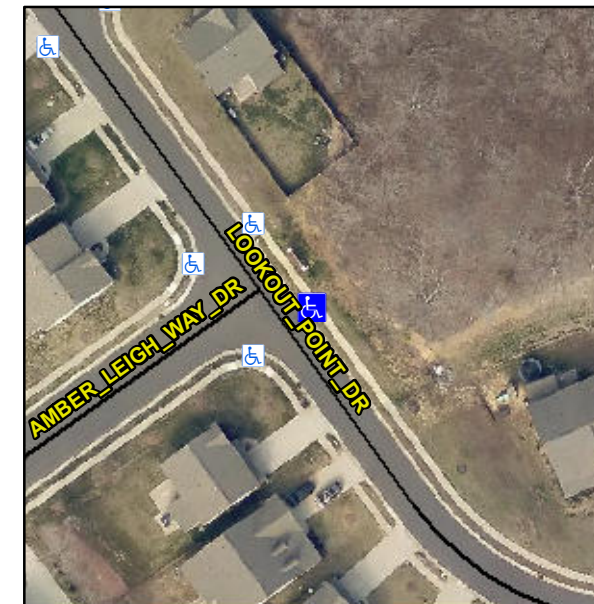
Not Found, R304.5.1, R304.2.2, R304.5.3

Compliance	Description	Data	Compliance	Description	Data
N/A	Ramp Length (in)	47.5	No	Ramp Slope (%)	8.8
No	Ramp Width (in)	47.0	No	Ramp XSlope (%)	2.8
N/A	Flare Type LT	N/A	N/A	Flare Type RT	N/A
N/A	Flare Slope LT (%)	N/A	N/A	Flare Slope RT (%)	N/A
N/A	Flare Traversable LT?	N/A	N/A	Flare Traversable RT?	N/A
N/A	Landing Length (in)	N/A	N/A	DWS Provided?	N/A
N/A	Landing Width (in)	N/A	N/A	DWS Contrast?	N/A
N/A	Landing Slope (%)	N/A	N/A	DWS Length (in)	N/A
N/A	Landing X Slope (%)	N/A	N/A	DWS Full Width?	N/A
N/A	Landing Curb? (Y/N)	N/A	N/A	DWS Offset (in)	N/A
N/A	Shared Landing?	N/A			
N/A	Gutter Ponding?	N/A	N/A	Gutter Slope (%)	N/A
N/A	Gutter Lip Ht (in)	N/A	N/A	Gutter X Slope (%)	N/A
N/A	Painted X Walk1?	No	N/A	Painted X Walk2?	N/A
	X Walk 1 Direction	To SW		X Walk 2 Direction	N/A
N/A	X Walk 1 Width (in)	N/A	N/A	X Walk 2 Width (in)	N/A
	X Walk 1 Slope (%)	2.5		X Walk 2 Slope (%)	N/A
	X Walk 1 X Slope (%)	1.7		X Walk 2 X Slope (%)	N/A

N/A	Ramp inside XWalk1?	N/A	N/A	Ramp inside XWalk2?	N/A
	Road Slope (%)	N/A	N/A	Clear Space?	N/A
	Road X Slope (%)	N/A	N/A	Clear Space to XWalk (in)	N/A
N/A	Any Obstructions?	N/A	N/A	Storm Grate/Utility Hazard?	N/A
	Obstruction Type			Storm Grate/Utility Type	
		N/A			N/A
			Yes	Surface Condition? (G/P)	Good

Possible Solutions:

Remove & Replace Entire Ramp.
