Access Compliance Report Public Rights-of-Way (Curb Ramps)

Intersection ID: 10017066 Main Street: NEAL_RD **Cross Street: N/A** Location: S **Overall Compliance: No** ADA ID: C7480E06E5BC Ramp Type: PerpDiag Initial Pass/Fail: Fail **Severity Score:** 25

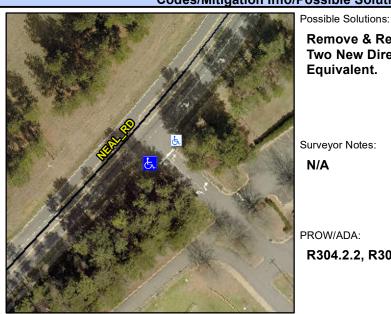
R304.2.2, R304.5.3

Comp	liance Description	Data	Comp	liance	Description	Data
N/A	Ramp Length (in)	97.0	No	Ramp	Slope (%)	10.8
Yes	Ramp Width (in)	57.0	No	Ramp	XSlope (%)	6.2
N/A	Flare Type LT	N/A	N/A	Flare	Type RT	N/A
N/A	Flare Slope LT (%)	N/A	N/A	Flare	Slope RT (%)	N/A
N/A	Flare Traversable LT?	N/A	N/A	Flare	Traversable RT?	N/A
N/A	Landing Length (in)	N/A	N/A	DWS	Provided?	N/A
N/A	Landing Width (in)	N/A	N/A	DWS	Contrast?	N/A
N/A	Landing Slope (%)	N/A	N/A	DWS	Length (in)	N/A
N/A	Landing X Slope (%)	N/A	N/A	DWS	Full Width?	N/A
N/A	Landing Curb? (Y/N)	N/A	N/A	DWS	Offset (in)	N/A
N/A	Shared Landing?	N/A				
N/A	Gutter Ponding?	N/A	N/A	Gutte	r Slope (%)	N/A
N/A	Gutter Lip Ht (in)	N/A	N/A	Gutte	r X Slope (%)	N/A
N/A	Painted X Walk1?	No	N/A	Painte	ed X Walk2?	No
	X Walk 1 Direction	To NE		X Wa	lk 2 Direction	To NW
N/A	X Walk 1 Width (in)	N/A	N/A	X Wa	lk 2 Width (in)	N/A
	X Walk 1 Slope (%)	2.2		X Wa	lk 2 Slope (%)	6.7
	X Walk 1 X Slope (%)	6.8		X Wa	lk 2 X Slope (%)	0.5

N/A	Ramp inside XWalk1?	N/A	N/A	Ramp	inside XWalk2?	N/A
	Road Slope (%)	5.7	N/A	Clear	Space?	N/A
	Road X Slope (%)	6.7	N/A	Clear	Space to XWalk (in)	N/A
N/A	Any Obstructions?	N/A	N/A	Storm	Grate/Utility Hazard?	N/A
	Obstruction Type			Storm	Grate/Utility Type	
		N/A				N/A

Remove & Replace Curb Ramp With Two New Directional Ramps or Equivalent.

Total Cost: 3200.00
