Access Compliance Report

Public Rights-of-Way

(Curb Ramps)

Intersection ID: 11463	Main Street: ABERDEEN_ST	Cross Street: WHITEHALL_DR	Location:	E
ADA ID: C74836A63131	Ramp Type: BlendTrans1	Initial Pass/Fail: Fail	Overall Compliance: No	Severity Score: 12.5
Codes/Mitigation Info/Possible Solution		Field Measurements/Component Compliance

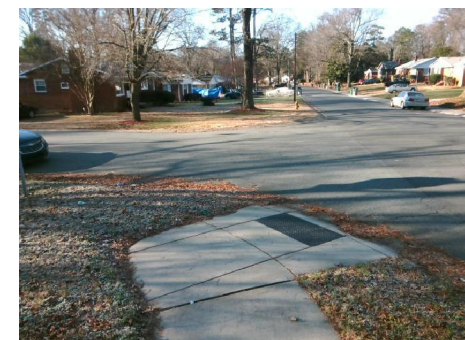
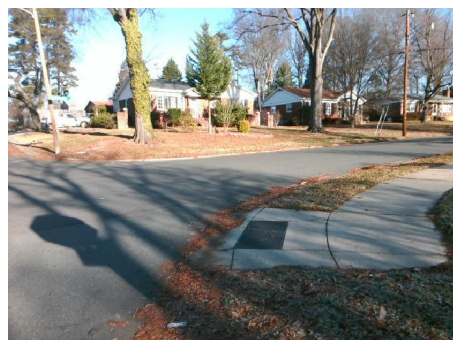
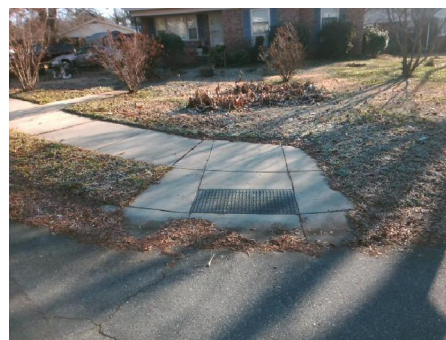
Not Found, R304.5.3

Compliance	Description	Data	Compliance	Description	Data
N/A	Ramp Length (in)	48.0	Yes	BlendTrans Slope (%)	3.3
Yes	Ramp Width (in)	48.0	No	BlendTrans XSlope (%)	5.4
N/A	Flare Type LT	N/A	N/A	Flare Type RT	N/A
N/A	Flare Slope LT (%)	N/A	N/A	Flare Slope RT (%)	N/A
N/A	Flare Traversable LT?	N/A	N/A	Flare Traversable RT?	N/A
N/A	Landing Length (in)	N/A	N/A	DWS Provided?	N/A
N/A	Landing Width (in)	N/A	N/A	DWS Contrast?	N/A
N/A	Landing Slope (%)	N/A	N/A	DWS Length (in)	N/A
N/A	Landing X Slope (%)	N/A	N/A	DWS Full Width?	N/A
N/A	Landing Curb? (Y/N)	N/A	N/A	DWS Offset (in)	N/A
N/A	Shared Landing?	N/A			
N/A	Gutter Ponding?	Yes	N/A	Gutter Slope (%)	N/A
N/A	Gutter Lip Ht (in)	N/A	N/A	Gutter X Slope (%)	N/A
N/A	Painted X Walk1?	No	N/A	Painted X Walk2?	No
	X Walk 1 Direction	To NW		X Walk 2 Direction	To SW
	X Walk 1 Width (in)	N/A		X Walk 2 Width (in)	N/A
	X Walk 1 Slope (%)	4.5		X Walk 2 Slope (%)	N/A
	X Walk 1 X Slope (%)	7.2		X Walk 2 X Slope (%)	N/A

N/A	Ramp inside XWalk1?	N/A	N/A	Ramp inside XWalk2?	N/A
	Road Slope (%)	7.2		Clear Space?	N/A
	Road X Slope (%)	4.5	N/A	Clear Space to XWalk (in)	N/A
N/A	Any Obstructions?	N/A	N/A	Storm Grate/Utility Hazard?	N/A
	Obstruction Type			Storm Grate/Utility Type	
		N/A			N/A
			Yes	Surface Condition? (G/P)	Good
			No	Curb Slope (%)	17.2

Remove & Replace Curb Ramp With Two New Directional Ramps or Equivalent.
