# Access Compliance Report

## Public Rights-of-Way

### (Curb Ramps)

Intersection ID: 14049	Main Street: CLEMENT_AV	Cross Street: PARK_DR	Location: E
ADA ID: C76138D66AC1	Ramp Type: PerpDiag	Initial Pass/Fail: Fail	Overall Compliance: No
Codes/Mitigation Info/Possible Solution		Field Measurements/Component Compliance	
Severity Score: 12.5

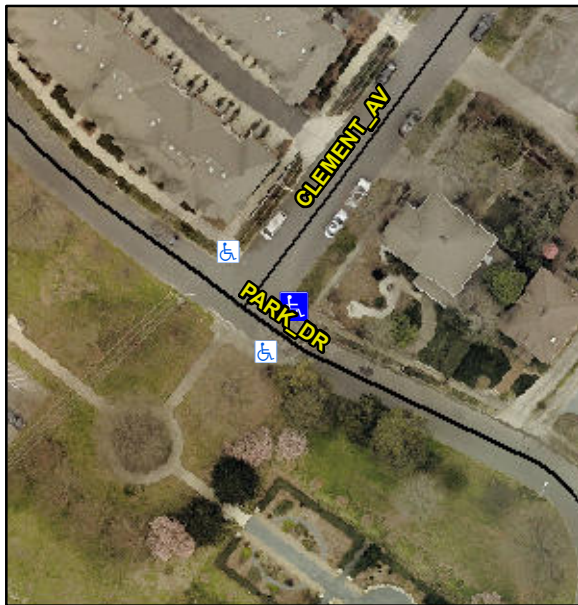
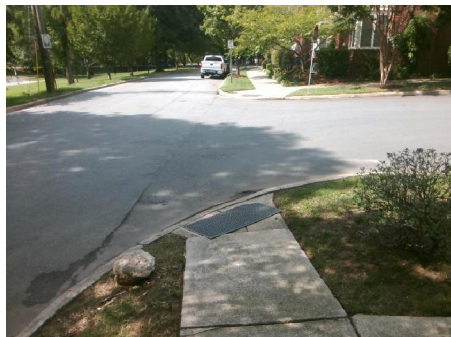
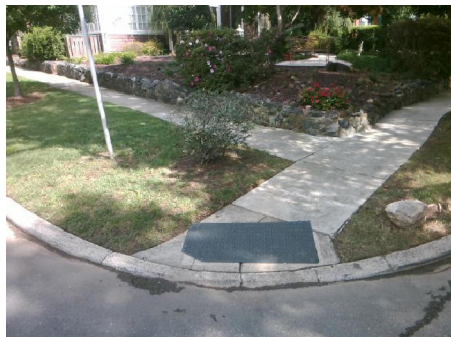
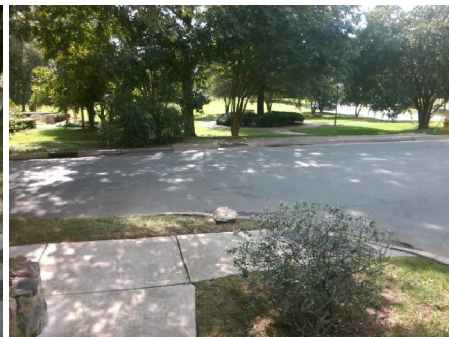
Compliance	Description	Data	Compliance	Description	Data
N/A	Ramp Length (in)	36.0	No	Ramp Slope (%)	10.7
Yes	Ramp Width (in)	48.0	Yes	Ramp XSlope (%)	2.0
N/A	Flare Type LT	N/A	N/A	Flare Type RT	N/A
N/A	Flare Slope LT (%)	N/A	N/A	Flare Slope RT (%)	N/A
N/A	Flare Traversable LT?	N/A	N/A	Flare Traversable RT?	N/A
N/A	Landing Length (in)	N/A	N/A	DWS Provided?	N/A
N/A	Landing Width (in)	N/A	N/A	DWS Contrast?	N/A
N/A	Landing Slope (%)	N/A	N/A	DWS Length (in)	N/A
N/A	Landing X Slope (%)	N/A	N/A	DWS Full Width?	N/A
N/A	Landing Curb? (Y/N)	N/A	N/A	DWS Offset (in)	N/A
N/A	Shared Landing?	N/A			
N/A	Gutter Ponding?	N/A	N/A	Gutter Slope (%)	N/A
N/A	Gutter Lip Ht (in)	N/A	N/A	Gutter X Slope (%)	N/A
N/A	Painted X Walk1?	No	N/A	Painted X Walk2?	No
	X Walk 1 Direction	To NW		X Walk 2 Direction	To SW
N/A	X Walk 1 Width (in)	N/A	N/A	X Walk 2 Width (in)	N/A
	X Walk 1 Slope (%)	5.4		X Walk 2 Slope (%)	3.3
	X Walk 1 X Slope (%)	3.0		X Walk 2 X Slope (%)	4.1

N/A	Ramp inside XWalk1?	N/A	N/A	Ramp inside XWalk2?	N/A
	Road Slope (%)	1.9	N/A	Clear Space?	N/A
	Road X Slope (%)	3.3	N/A	Clear Space to XWalk (in)	N/A
N/A	Any Obstructions?	N/A	N/A	Storm Grate/Utility Hazard?	N/A
	Obstruction Type			Storm Grate/Utility Type	
		N/A			N/A
			Yes	Surface Condition? (G/P)	Good

**Remove & Replace Curb Ramp With Two New Directional Ramps or Equivalent.**

**Not Found, R304.2.2**
