Access Compliance Report

Public Rights-of-Way

(Curb Ramps)

Intersection ID: 18238	Main Street: QUEEN ANNE RD	Cross Street: S TRYON ST	Location: SE
ADA ID: C767E140FDBC	Ramp Type: Directional1	Initial Pass/Fail: Fail	Overall Compliance: No
Severity Score: 1.25			
Codes/Mitigation Info/Possible Solution		Field Measurements/Component Compliance

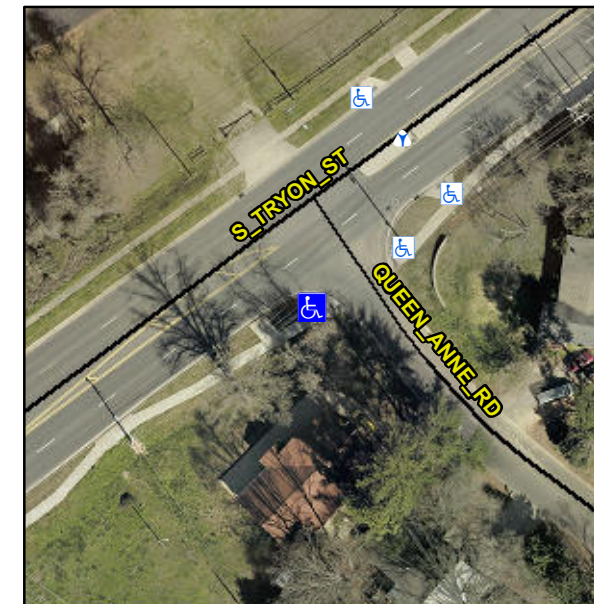
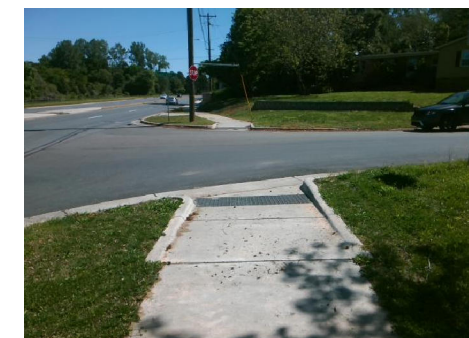
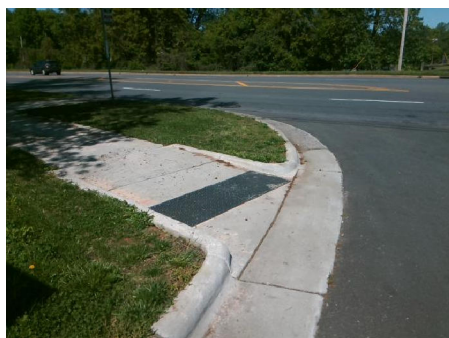
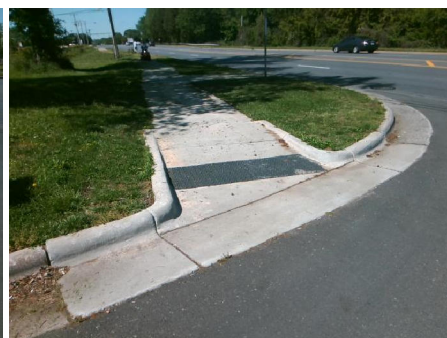
Compliance	Description	Data	Compliance	Description	Data
N/A	Ramp Length (in)	55.0	N/A	Grade Break?	N/A
Yes	Ramp Width (in)	69.0	N/A	Grade Break Slope (%)	0.0
Yes	Ramp Slope (%)	5.8	N/A	Grade Break XSlope (%)	0.0
No	Ramp XSlope (%)	2.2			
N/A	Flare Type LT	N/A	N/A	Flare Type RT	N/A
N/A	Flare Slope LT (%)	N/A	N/A	Flare Slope RT (%)	0.0
N/A	Flare Traversable LT?	N/A	N/A	Flare Traversable RT?	N/A
N/A	Landing Length (in)	0.0	N/A	DWS Provided?	N/A
N/A	Landing Width (in)	0.0	N/A	DWS Contrast?	N/A
N/A	Landing Slope (%)	0.0	N/A	DWS Length (in)	N/A
N/A	Landing X Slope (%)	0.0	N/A	DWS Full Width?	N/A
N/A	Landing Curb? (Y/N)	N/A	N/A	DWS Offset LT (in)	N/A
N/A	Shared Landing?	N/A	N/A	DWS Offset RT (in)	N/A
N/A	Gutter Ponding?	0.0	N/A	Gutter Slope (%)	N/A
N/A	Gutter Lip Ht (in)	0.0	N/A	Gutter X Slope (%)	N/A
N/A	Painted X Walk1?	No		Road Slope (%)	1.5
	X Walk 1 Direction	To NE		Road X Slope (%)	1.2
	X Walk 1 Width (in)	N/A		Clear Space?	N/A

X Walk 1 Slope (%)	1.5	N/A	Clear Space to XWalk (in)	N/A
	X Walk 1 X Slope (%)	1.2	N/A	Storm Grate/Utility Hazard?	N/A
N/A	Ramp inside XWalk1?	N/A		Storm Grate/Utility Type	
N/A	Any Obstructions?	N/A			N/A
	Obstruction Type		Yes	Surface Condition? (G/P)	Good
			N/A	Curb Slope (%)	2.2

Possible Solutions:

Remove & Replace Entire Ramp.

R304.5.3
