Access Compliance Report

Public Rights-of-Way

(Curb Ramps)

Intersection ID: 48792	Main Street: WOODLAND_WATCH_CT	Cross Street: COMMUNITY_HOUSE_RD	Location: NE
ADA ID: C76B615C32BE	Ramp Type: PerpDiag	Initial Pass/Fail: Fail	Overall Compliance: No
Severity Score: 12.5			
Codes/Mitigation Info/Possible Solution		Field Measurements/Component Compliance

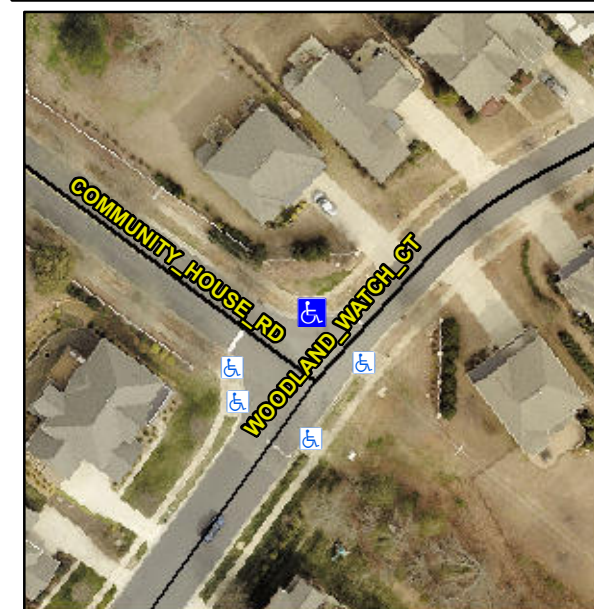
Not Found, R304.2.2

Compliance	Description	Data	Compliance	Description	Data
N/A	Ramp Length (in)	72.0	No	Ramp Slope (%)	9.1
Yes	Ramp Width (in)	53.0	Yes	Ramp XSlope (%)	0.8
N/A	Flare Type LT	N/A	N/A	Flare Type RT	N/A
N/A	Flare Slope LT (%)	N/A	N/A	Flare Slope RT (%)	N/A
N/A	Flare Traversable LT?	N/A	N/A	Flare Traversable RT?	N/A
N/A	Landing Length (in)	N/A	N/A	DWS Provided?	N/A
N/A	Landing Width (in)	N/A	N/A	DWS Contrast?	N/A
N/A	Landing Slope (%)	N/A	N/A	DWS Length (in)	N/A
N/A	Landing X Slope (%)	N/A	N/A	DWS Full Width?	N/A
N/A	Landing Curb? (Y/N)	N/A	N/A	DWS Offset (in)	N/A
N/A	Shared Landing?	N/A			
N/A	Gutter Ponding?	N/A	N/A	Gutter Slope (%)	N/A
N/A	Gutter Lip Ht (in)	N/A	N/A	Gutter X Slope (%)	N/A
N/A	Painted X Walk1?	No	N/A	Painted X Walk2?	No
	X Walk 1 Direction	To SW		X Walk 2 Direction	To SE
N/A	X Walk 1 Width (in)	N/A	N/A	X Walk 2 Width (in)	N/A
	X Walk 1 Slope (%)	0.3		X Walk 2 Slope (%)	0.6
	X Walk 1 X Slope (%)	0.6		X Walk 2 X Slope (%)	1.0

N/A	Ramp inside XWalk1?	N/A	N/A	Ramp inside XWalk2?	N/A
	Road Slope (%)	1.5	N/A	Clear Space?	N/A
	Road X Slope (%)	0.8	N/A	Clear Space to XWalk (in)	N/A
N/A	Any Obstructions?	N/A	N/A	Storm Grate/Utility Hazard?	N/A
	Obstruction Type			Storm Grate/Utility Type	
		N/A			N/A
		Yes		Surface Condition? (G/P)	Good

Possible Solutions:

Remove & Replace Curb Ramp With Two New Directional Ramps or Equivalent.
