Access Compliance Report

Public Rights-of-Way

(Curb Ramps)

Intersection ID: 10011781	Main Street: PIERSON_DR	Cross Street: N/A	Location: S
ADA ID: C76E279CE9C1	Ramp Type: Perp	Initial Pass/Fail: Fail	Overall Compliance: No
		Severity Score: 25

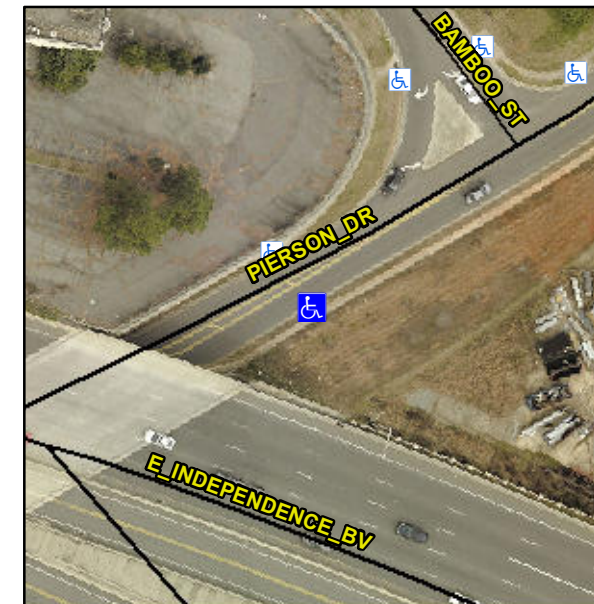
Not Found, R304.5.3

Compliance	Description	Data	Compliance	Description	Data
N/A	Ramp Length (in)	85.0	Yes	Ramp Slope (%)	8.1
Yes	Ramp Width (in)	70.0	No	Ramp XSlope (%)	7.1
N/A	Flare Type LT	N/A	N/A	Flare Type RT	N/A
N/A	Flare Slope LT (%)	N/A	N/A	Flare Slope RT (%)	N/A
N/A	Flare Traversable LT?	N/A	N/A	Flare Traversable RT?	N/A
N/A	Landing Length (in)	N/A	N/A	DWS Provided?	N/A
N/A	Landing Width (in)	N/A	N/A	DWS Contrast?	N/A
N/A	Landing Slope (%)	N/A	N/A	DWS Length (in)	N/A
N/A	Landing X Slope (%)	N/A	N/A	DWS Full Width?	N/A
N/A	Landing Curb? (Y/N)	N/A	N/A	DWS Offset (in)	N/A
N/A	Shared Landing?	N/A			
N/A	Gutter Ponding?	N/A	N/A	Gutter Slope (%)	N/A
N/A	Gutter Lip Ht (in)	N/A	N/A	Gutter X Slope (%)	N/A
N/A	Painted X Walk1?	No	N/A	Painted X Walk2?	N/A
	X Walk 1 Direction	To N		X Walk 2 Direction	N/A
N/A	X Walk 1 Width (in)	N/A	N/A	X Walk 2 Width (in)	N/A
	X Walk 1 Slope (%)	2.8		X Walk 2 Slope (%)	N/A
	X Walk 1 X Slope (%)	6.3		X Walk 2 X Slope (%)	N/A

N/A	Ramp inside XWalk1?	N/A	N/A	Ramp inside XWalk2?	N/A
	Road Slope (%)	N/A	N/A	Clear Space?	N/A
	Road X Slope (%)	N/A	N/A	Clear Space to XWalk (in)	N/A
N/A	Any Obstructions?	N/A	N/A	Storm Grate/Utility Hazard?	N/A
	Obstruction Type			Storm Grate/Utility Type	
		N/A			N/A
			Yes	Surface Condition? (G/P)	Good

Remove & Replace Entire Ramp.
