Access Compliance Report

Public Rights-of-Way

(Curb Ramps)

Intersection ID: 50637	Main Street: RED_WATER_RD	Cross Street: TOM_SHORT_RD	Location: NW
ADA ID: C77CE7E7749C	Ramp Type: Combination1	Initial Pass/Fail: Fail	Overall Compliance: No
Severity Score: 13.75			
Codes/Mitigation Info/Possible Solution		Field Measurements/Component Compliance

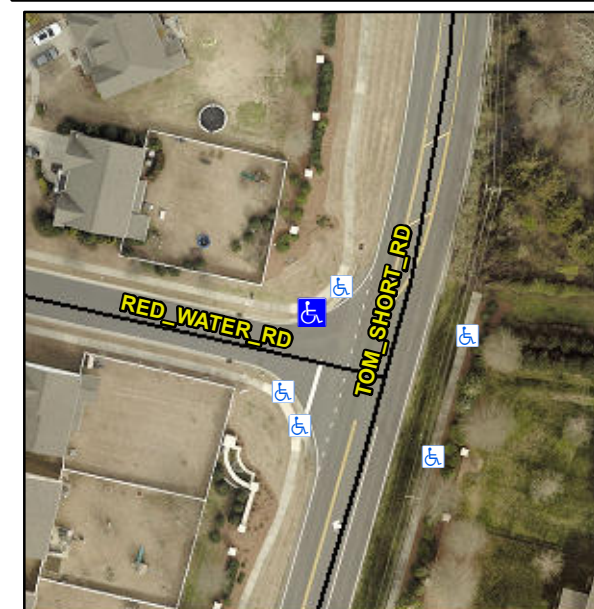
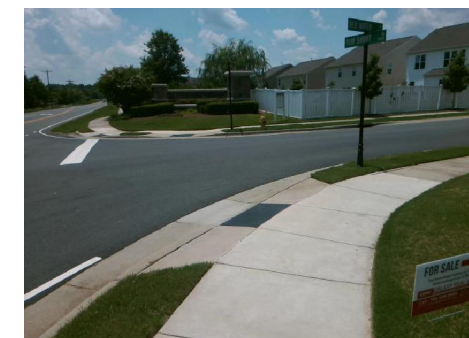
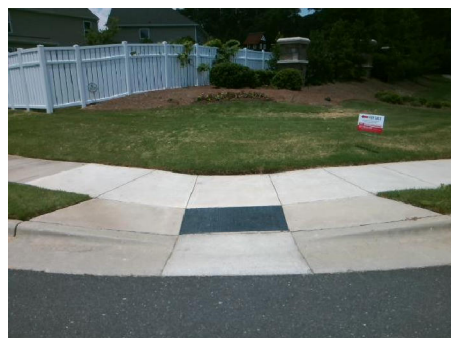
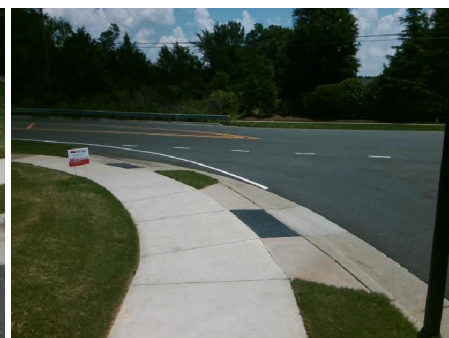
Not Found, R304.2.2, R304.5.3, R304.3.2

Compliance	Description	Data	Compliance	Description	Data
N/A	Ramp Length LT (in)	32.0	N/A	Ramp Length RT (in)	38.0
Yes	Ramp Width LT (in)	60.0	Yes	Ramp Width RT (in)	60.0
No	Ramp Slope LT (%)	8.9	Yes	Ramp Slope RT (%)	7.0
Yes	Ramp XSlope LT (%)	1.8	Yes	Ramp XSlope RT (%)	1.0
N/A	Ramp Length (in)	25.0	No	Ramp Slope (%)	11.4
Yes	Ramp Width (in)	48.0	No	Ramp XSlope (%)	2.5
N/A	Flare Type LT	N/A	N/A	Flare Type RT	N/A
N/A	Flare Slope LT (%)	N/A	N/A	Flare Slope RT (%)	N/A
N/A	Flare Traversable LT?	N/A	N/A	Flare Traversable RT?	N/A
N/A	Landing Length (in)	N/A	N/A	DWS Provided?	N/A
N/A	Landing Width (in)	N/A	N/A	DWS Contrast?	N/A
N/A	Landing Slope (%)	N/A	N/A	DWS Length (in)	N/A
N/A	Landing X Slope (%)	N/A	N/A	DWS Full Width?	N/A
N/A	Landing Curb? (Y/N)	N/A	N/A	DWS Offset (in)	N/A
N/A	Shared Landing?	N/A			
N/A	Gutter Ponding?	N/A	N/A	Gutter Slope (%)	N/A
N/A	Gutter Lip Ht (in)	N/A	N/A	Gutter X Slope (%)	N/A
N/A	Painted X Walk1?	No	N/A	Painted X Walk2?	N/A

X Walk 1 Direction	To SW		X Walk 2 Direction	N/A
	X Walk 1 Width (in)	N/A		X Walk 2 Width (in)	N/A
	X Walk 1 Slope (%)	1.0		X Walk 2 Slope (%)	N/A
	X Walk 1 X Slope (%)	1.1		X Walk 2 X Slope (%)	N/A
N/A	Ramp inside XWalk1?	N/A	N/A	Ramp inside XWalk2?	N/A
	Road Slope (%)	N/A		Clear Space?	N/A
	Road X Slope (%)	N/A	N/A	Clear Space to XWalk (in)	N/A
			N/A	Any Obstruction?	N/A
				Obstruction Type	N/A
			N/A	Storm Grate/Utility Hazard?	N/A
				Storm Grate/Utility Type	N/A
			Yes	Surface Condition? (G/P)	Good
				Curb Slope (%)	24.0

Remove & Replace Entire Ramp.
