# Access Compliance Report

## Public Rights-of-Way

### (Curb Ramps)

| Intersection ID: 49893 | Main Street: ROCKY_FORD_CLUB_RD | Cross Street: RIDGEVIEW_COMMONS_DR | Location: E |

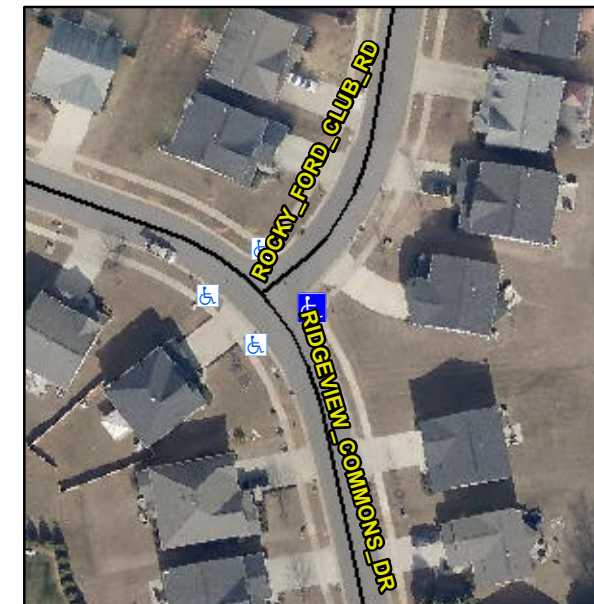
**Not Found, R304.2.1, R302.7.2**

| Compliance | Description | Data | Compliance | Description | Data |
|---|---|---|---|---|---|
| No | Landing Width (in) | 37.5 | Yes | DWS Contrast? | Yes |
| No | Gutter Lip Ht (in) | 0.5 | Yes | Gutter X Slope (%) | 0.2 |

**Remove & Replace Curb Ramp With Two New Directional Ramps or Equivalent.**
