# Access Compliance Report

## Public Rights-of-Way

### (Curb Ramps)

Intersection ID: 28212	Main Street: CHASEWATER_DR	Cross Street: DARBY_CHASE_DR	Location: E
ADA ID: C79ACA1DD723	Ramp Type: PerpDiag	Initial Pass/Fail: Fail	Overall Compliance: No
Severity Score: 12.5			
Codes/Mitigation Info/Possible Solution		Field Measurements/Component Compliance

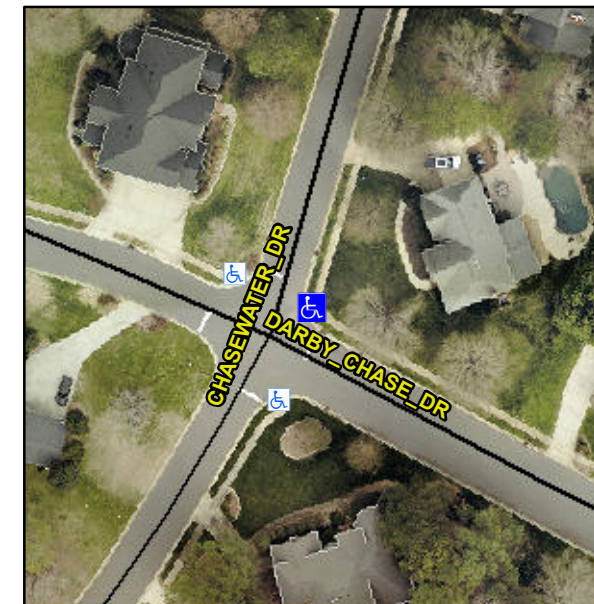
**Not Found, R304.2.2**

Compliance	Description	Data	Compliance	Description	Data
N/A	Ramp Length (in)	48.0	No	Ramp Slope (%)	8.4
Yes	Ramp Width (in)	48.0	Yes	Ramp XSlope (%)	2.0
N/A	Flare Type LT	N/A	N/A	Flare Type RT	N/A
N/A	Flare Slope LT (%)	N/A	N/A	Flare Slope RT (%)	N/A
N/A	Flare Traversable LT?	N/A	N/A	Flare Traversable RT?	N/A
N/A	Landing Length (in)	N/A	N/A	DWS Provided?	N/A
N/A	Landing Width (in)	N/A	N/A	DWS Contrast?	N/A
N/A	Landing Slope (%)	N/A	N/A	DWS Length (in)	N/A
N/A	Landing X Slope (%)	N/A	N/A	DWS Full Width?	N/A
N/A	Landing Curb? (Y/N)	N/A	N/A	DWS Offset (in)	N/A
N/A	Shared Landing?	N/A			
N/A	Gutter Ponding?	N/A	N/A	Gutter Slope (%)	N/A
N/A	Gutter Lip Ht (in)	N/A	N/A	Gutter X Slope (%)	N/A
N/A	Painted X Walk1?	No	N/A	Painted X Walk2?	No
	X Walk 1 Direction	To NW		X Walk 2 Direction	To SW
N/A	X Walk 1 Width (in)	N/A	N/A	X Walk 2 Width (in)	N/A
	X Walk 1 Slope (%)	1.6		X Walk 2 Slope (%)	1.1
	X Walk 1 X Slope (%)	0.9		X Walk 2 X Slope (%)	1.5

N/A	Ramp inside XWalk1?	N/A	N/A	Ramp inside XWalk2?	N/A
	Road Slope (%)	0.5	N/A	Clear Space?	N/A
	Road X Slope (%)	0.3	N/A	Clear Space to XWalk (in)	N/A
N/A	Any Obstructions?	N/A	N/A	Storm Grate/Utility Hazard?	N/A
	Obstruction Type			Storm Grate/Utility Type	
		N/A			N/A
		Yes		Surface Condition? (G/P)	Good

**Remove & Replace Curb Ramp With Two New Directional Ramps or Equivalent.**

Total Cost: \$ 3200.00
