# Access Compliance Report

## Public Rights-of-Way

### (Curb Ramps)

Intersection ID: 50710	Main Street: STEELE_CREEK_RD	Cross Street: ARRIVAL_DR	Location: SW
ADA ID: C79C1101DCC1	Ramp Type: Para	Initial Pass/Fail: Fail	Overall Compliance: No
Codes/Mitigation Info/Possible Solution			Severity Score: 10
			Field Measurements/Component Compliance

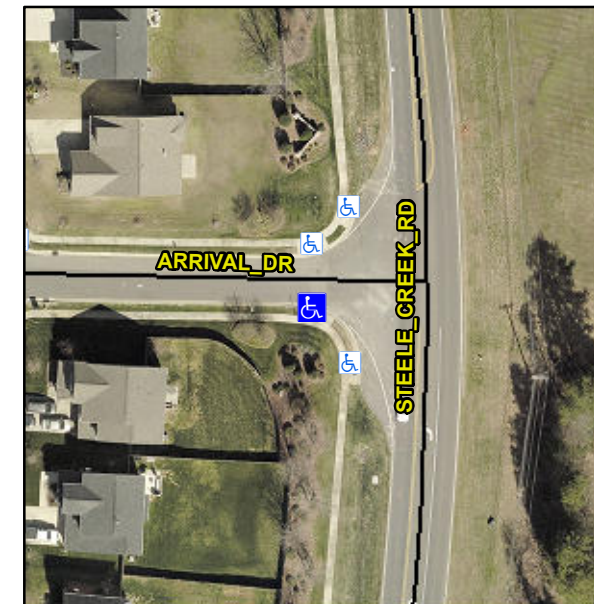
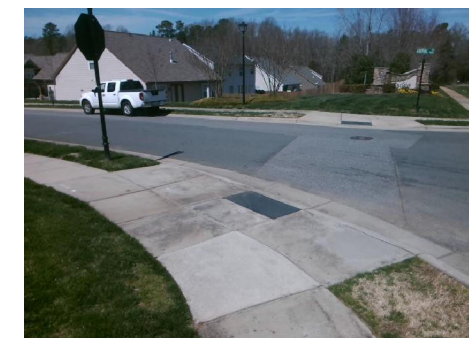
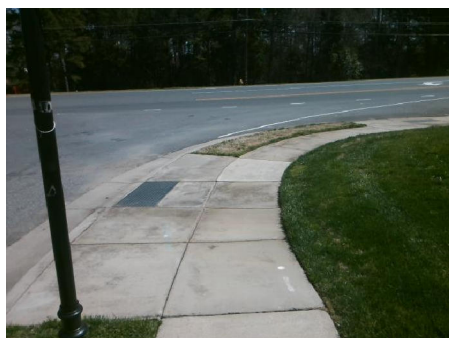
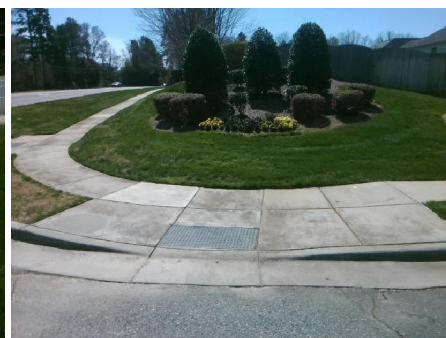
Compliance	Description	Data	Compliance	Description	Data
N/A	Ramp Length LT (in)	52.0	N/A	Ramp Length RT (in)	93.0
No	Ramp Width LT (in)	46.0	No	Ramp Width RT (in)	41.5
Yes	Ramp Slope LT (%)	5.0	Yes	Ramp Slope RT (%)	5.4
No	Ramp XSlope LT (%)	2.1	No	Ramp XSlope RT (%)	3.5
N/A	Landing Length (in)	N/A	N/A	DWS Provided?	N/A
N/A	Landing Width (in)	N/A	N/A	DWS Contrast?	N/A
N/A	Landing Slope (%)	N/A	N/A	DWS Length (in)	N/A
N/A	Landing X Slope (%)	N/A	N/A	DWS Full Width?	N/A
N/A	Landing Curb? (Y/N)	N/A	N/A	DWS Offset (in)	N/A
N/A	Shared Landing?	N/A			
N/A	Gutter Ponding?	N/A	N/A	Gutter Slope (%)	N/A
N/A	Gutter Lip Ht (in)	N/A	N/A	Gutter X Slope (%)	N/A
N/A	Painted X Walk1?	No	N/A	Painted X Walk2?	N/A
	X Walk 1 Direction	To N		X Walk 2 Direction	N/A
N/A	X Walk 1 Width (in)	N/A	N/A	X Walk 2 Width (in)	N/A
	X Walk 1 Slope (%)	0.9		X Walk 2 Slope (%)	N/A
	X Walk 1 X Slope (%)	0.9		X Walk 2 X Slope (%)	N/A
N/A	Ramp inside XWalk1?	N/A	N/A	Ramp inside XWalk2?	N/A

Road Slope (%)	N/A	N/A	Clear Space?	N/A
	Road X Slope (%)	N/A	N/A	Clear Space to XWalk (in)	N/A
N/A	Any Obstructions?	N/A	N/A	Storm Grate/Utility Hazard?	N/A
	Obstruction Type			Storm Grate/Utility Type	
		N/A			N/A
			Yes	Surface Condition? (G/P)	Good
			N/A	Curb Slope (%)	9.3

**Remove & Replace Entire Ramp.**

**R304.5.1, R304.5.3**
