# Access Compliance Report

## Public Rights-of-Way

### (Curb Ramps)

Intersection ID: 27777	Main Street: BRIARWICK_LN	Cross Street: MOSS_MILL_LN	Location: SW
ADA ID: C7A559EBBD2B	Ramp Type: PerpDiag	Initial Pass/Fail: Fail	Overall Compliance: No
		Severity Score: 37.5

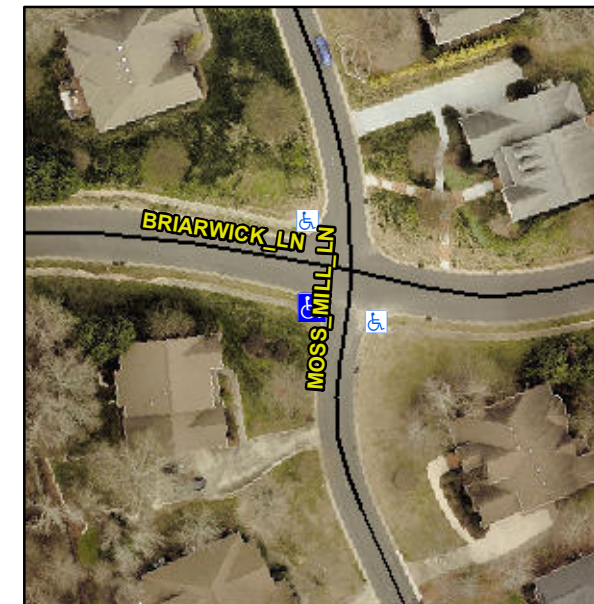
**Not Found, R304.2.2, R304.5.3**

Compliance	Description	Data	Compliance	Description	Data
N/A	Ramp Length (in)	97.0	No	Ramp Slope (%)	8.7
Yes	Ramp Width (in)	48.0	No	Ramp XSlope (%)	10.9
N/A	Flare Type LT	N/A	N/A	Flare Type RT	N/A
N/A	Flare Slope LT (%)	N/A	N/A	Flare Slope RT (%)	N/A
N/A	Flare Traversable LT?	N/A	N/A	Flare Traversable RT?	N/A
N/A	Landing Length (in)	N/A	N/A	DWS Provided?	N/A
N/A	Landing Width (in)	N/A	N/A	DWS Contrast?	N/A
N/A	Landing Slope (%)	N/A	N/A	DWS Length (in)	N/A
N/A	Landing X Slope (%)	N/A	N/A	DWS Full Width?	N/A
N/A	Landing Curb? (Y/N)	N/A	N/A	DWS Offset (in)	N/A
N/A	Shared Landing?	N/A			
N/A	Gutter Ponding?	N/A	N/A	Gutter Slope (%)	N/A
N/A	Gutter Lip Ht (in)	N/A	N/A	Gutter X Slope (%)	N/A
N/A	Painted X Walk1?	No	N/A	Painted X Walk2?	No
	X Walk 1 Direction	To SE		X Walk 2 Direction	To NE
N/A	X Walk 1 Width (in)	N/A	N/A	X Walk 2 Width (in)	N/A
	X Walk 1 Slope (%)	2.8		X Walk 2 Slope (%)	1.6
	X Walk 1 X Slope (%)	3.2		X Walk 2 X Slope (%)	5.2

N/A	Ramp inside XWalk1?	N/A	N/A	Ramp inside XWalk2?	N/A
	Road Slope (%)	5.4	N/A	Clear Space?	N/A
	Road X Slope (%)	1.0	N/A	Clear Space to XWalk (in)	N/A
N/A	Any Obstructions?	N/A	N/A	Storm Grate/Utility Hazard?	N/A
	Obstruction Type			Storm Grate/Utility Type	
		N/A			N/A
			Yes	Surface Condition? (G/P)	Good

**Remove & Replace Curb Ramp With Two New Directional Ramps or Equivalent.**
