Access Compliance Report

Public Rights-of-Way

(Curb Ramps)

Intersection ID: N/A	Main Street: SPEER_BV	Cross Street: NATIONAL_AV	Location: W
ADA ID: C7A794AB50BC	Ramp Type: Perp	Initial Pass/Fail: Fail	Overall Compliance: No
Severity Score: 12.5			
Codes/Mitigation Info/Possible Solution		Field Measurements/Component Compliance

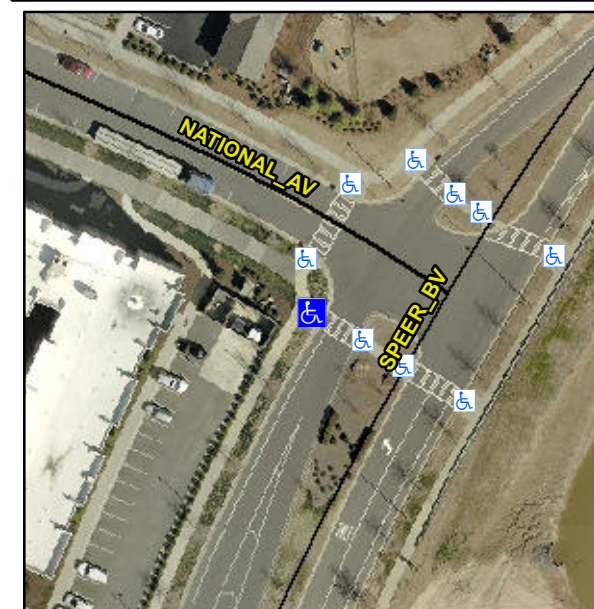
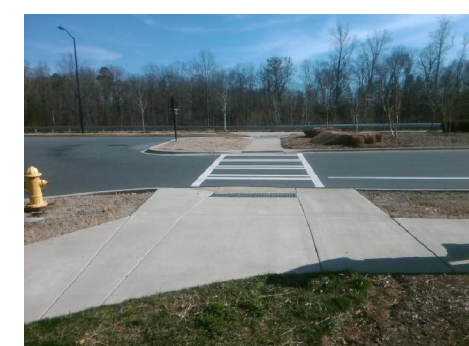
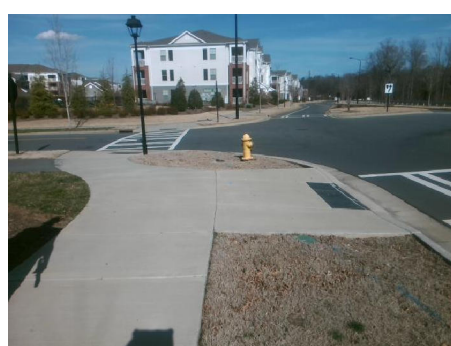
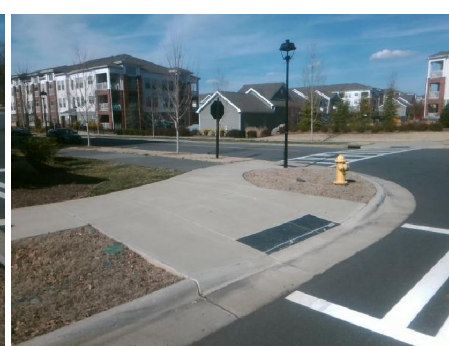
Not Found, R304.2.2

Compliance	Description	Data	Compliance	Description	Data
N/A	Ramp Length (in)	96.0	No	Ramp Slope (%)	8.6
Yes	Ramp Width (in)	71.0	Yes	Ramp XSlope (%)	1.2
N/A	Flare Type LT	N/A	N/A	Flare Type RT	N/A
N/A	Flare Slope LT (%)	N/A	N/A	Flare Slope RT (%)	N/A
N/A	Flare Traversable LT?	N/A	N/A	Flare Traversable RT?	N/A
N/A	Landing Length (in)	N/A	N/A	DWS Provided?	N/A
N/A	Landing Width (in)	N/A	N/A	DWS Contrast?	N/A
N/A	Landing Slope (%)	N/A	N/A	DWS Length (in)	N/A
N/A	Landing X Slope (%)	N/A	N/A	DWS Full Width?	N/A
N/A	Landing Curb? (Y/N)	N/A	N/A	DWS Offset (in)	N/A
N/A	Shared Landing?	N/A			
N/A	Gutter Ponding?	N/A	N/A	Gutter Slope (%)	N/A
N/A	Gutter Lip Ht (in)	N/A	N/A	Gutter X Slope (%)	N/A
N/A	Painted X Walk1?	Yes	N/A	Painted X Walk2?	N/A
	X Walk 1 Direction	To SE		X Walk 2 Direction	N/A
N/A	X Walk 1 Width (in)	112.0	N/A	X Walk 2 Width (in)	N/A
	X Walk 1 Slope (%)	4.2		X Walk 2 Slope (%)	N/A
	X Walk 1 X Slope (%)	2.6		X Walk 2 X Slope (%)	N/A

N/A	Ramp inside XWalk1?	Yes	N/A	Ramp inside XWalk2?	N/A
	Road Slope (%)	N/A	N/A	Clear Space?	N/A
	Road X Slope (%)	N/A	N/A	Clear Space to XWalk (in)	N/A
N/A	Any Obstructions?	N/A	N/A	Storm Grate/Utility Hazard?	N/A
	Obstruction Type			Storm Grate/Utility Type	
		N/A			N/A
			Yes	Surface Condition? (G/P)	Good

Remove & Replace Entire Ramp.

Total Cost: \$ 1850.00
