# Access Compliance Report

## Public Rights-of-Way

### (Curb Ramps)

Intersection ID: 7767	Main Street: OLD_LITTLE_ROCK_RD	Cross Street: FLINTROCK_RD	Location: W
ADA ID: C7ADB221CE0C	Ramp Type: Perp	Initial Pass/Fail: Fail	Overall Compliance: No
Severity Score: 21.25			
Codes/Mitigation Info/Possible Solution		Field Measurements/Component Compliance

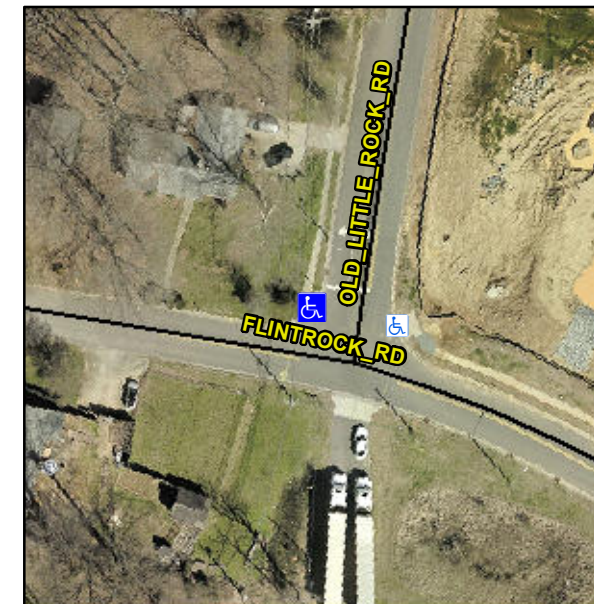
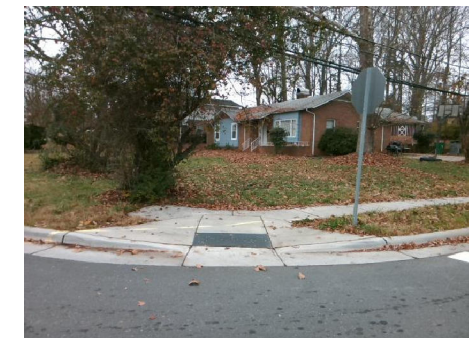
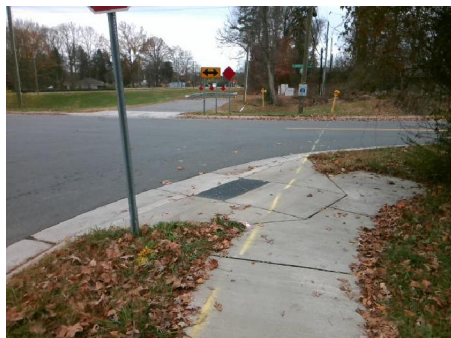
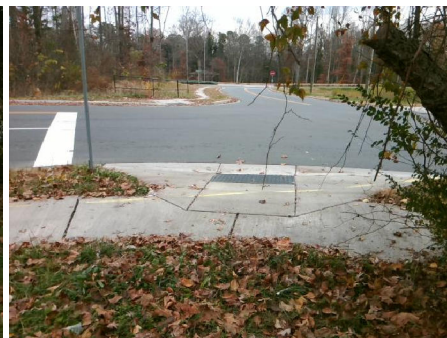
**Not Found, R304.5.1, R304.2.2**

Compliance	Description	Data	Compliance	Description	Data
N/A	Ramp Length (in)	73.0	No	Ramp Slope (%)	9.0
No	Ramp Width (in)	46.0	Yes	Ramp XSlope (%)	1.7
N/A	Flare Type LT	N/A	N/A	Flare Type RT	N/A
N/A	Flare Slope LT (%)	N/A	N/A	Flare Slope RT (%)	N/A
N/A	Flare Traversable LT?	N/A	N/A	Flare Traversable RT?	N/A
N/A	Landing Length (in)	N/A	N/A	DWS Provided?	N/A
N/A	Landing Width (in)	N/A	N/A	DWS Contrast?	N/A
N/A	Landing Slope (%)	N/A	N/A	DWS Length (in)	N/A
N/A	Landing X Slope (%)	N/A	N/A	DWS Full Width?	N/A
N/A	Landing Curb? (Y/N)	N/A	N/A	DWS Offset (in)	N/A
N/A	Shared Landing?	N/A			
N/A	Gutter Ponding?	N/A	N/A	Gutter Slope (%)	N/A
N/A	Gutter Lip Ht (in)	N/A	N/A	Gutter X Slope (%)	N/A
N/A	Painted X Walk1?	No	N/A	Painted X Walk2?	N/A
	X Walk 1 Direction	To SE		X Walk 2 Direction	N/A
N/A	X Walk 1 Width (in)	N/A	N/A	X Walk 2 Width (in)	N/A
	X Walk 1 Slope (%)	0.3		X Walk 2 Slope (%)	N/A
	X Walk 1 X Slope (%)	1.2		X Walk 2 X Slope (%)	N/A

N/A	Ramp inside XWalk1?	N/A	N/A	Ramp inside XWalk2?	N/A
	Road Slope (%)	N/A	N/A	Clear Space?	N/A
	Road X Slope (%)	N/A	N/A	Clear Space to XWalk (in)	N/A
N/A	Any Obstructions?	N/A	N/A	Storm Grate/Utility Hazard?	N/A
	Obstruction Type			Storm Grate/Utility Type	
		N/A			N/A
			Yes	Surface Condition? (G/P)	Good

**Remove & Replace Entire Ramp.**

Total Cost: \$ 1850.00
