# Access Compliance Report

## Public Rights-of-Way

### (Curb Ramps)

Intersection ID: 44836	Main Street: PARKDALE_DR	Cross Street: THRIFTWOOD_DR	Location:	N
ADA ID: C7AFF579B66D	Ramp Type: Perp	Initial Pass/Fail: Fail	Overall Compliance: No	Severity Score: 1.25
Codes/Mitigation Info/Possible Solution		Field Measurements/Component Compliance

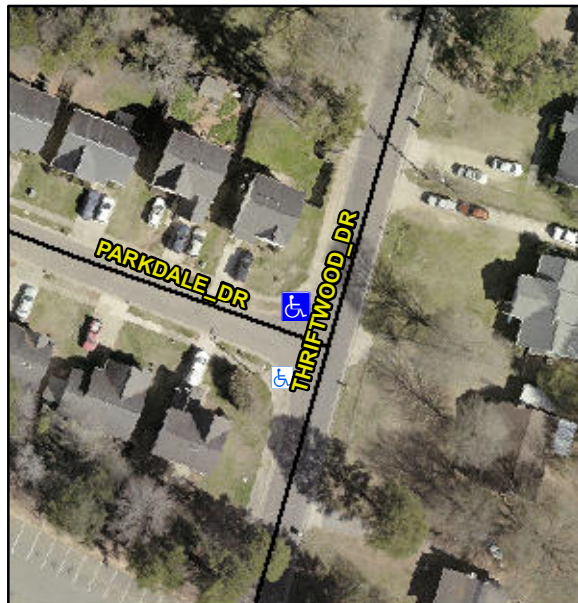
Compliance	Description	Data	Compliance	Description	Data
N/A	Ramp Length (in)	48.0	Yes	Ramp Slope (%)	6.2
Yes	Ramp Width (in)	53.0	No	Ramp XSlope (%)	4.1
N/A	Flare Type LT	N/A	N/A	Flare Type RT	N/A
N/A	Flare Slope LT (%)	N/A	N/A	Flare Slope RT (%)	N/A
N/A	Flare Traversable LT?	N/A	N/A	Flare Traversable RT?	N/A
N/A	Landing Length (in)	N/A	N/A	DWS Provided?	N/A
N/A	Landing Width (in)	N/A	N/A	DWS Contrast?	N/A
N/A	Landing Slope (%)	N/A	N/A	DWS Length (in)	N/A
N/A	Landing X Slope (%)	N/A	N/A	DWS Full Width?	N/A
N/A	Landing Curb? (Y/N)	N/A	N/A	DWS Offset (in)	N/A
N/A	Shared Landing?	N/A			
N/A	Gutter Ponding?	N/A	N/A	Gutter Slope (%)	N/A
N/A	Gutter Lip Ht (in)	N/A	N/A	Gutter X Slope (%)	N/A
N/A	Painted X Walk1?	No	N/A	Painted X Walk2?	N/A
	X Walk 1 Direction	To SW		X Walk 2 Direction	N/A
N/A	X Walk 1 Width (in)	N/A	N/A	X Walk 2 Width (in)	N/A
	X Walk 1 Slope (%)	2.7		X Walk 2 Slope (%)	N/A
	X Walk 1 X Slope (%)	2.1		X Walk 2 X Slope (%)	N/A

N/A	Ramp inside XWalk1?	N/A	N/A	Ramp inside XWalk2?	N/A
	Road Slope (%)	N/A	N/A	Clear Space?	N/A
	Road X Slope (%)	N/A	N/A	Clear Space to XWalk (in)	N/A
N/A	Any Obstructions?	N/A	N/A	Storm Grate/Utility Hazard?	N/A
	Obstruction Type			Storm Grate/Utility Type	
		N/A			N/A
			Yes	Surface Condition? (G/P)	Good

**Remove & Replace Entire Ramp.**
