# Access Compliance Report

## Public Rights-of-Way

### (Curb Ramps)

Intersection ID: 14078	Main Street: EAST_BV	Cross Street: SOUTH_BV	Location: SE
ADA ID: C7B9C232A8DD	Ramp Type: Perp	Initial Pass/Fail: Fail	Overall Compliance: No
Severity Score: 8.75			
Codes/Mitigation Info/Possible Solution		Field Measurements/Component Compliance

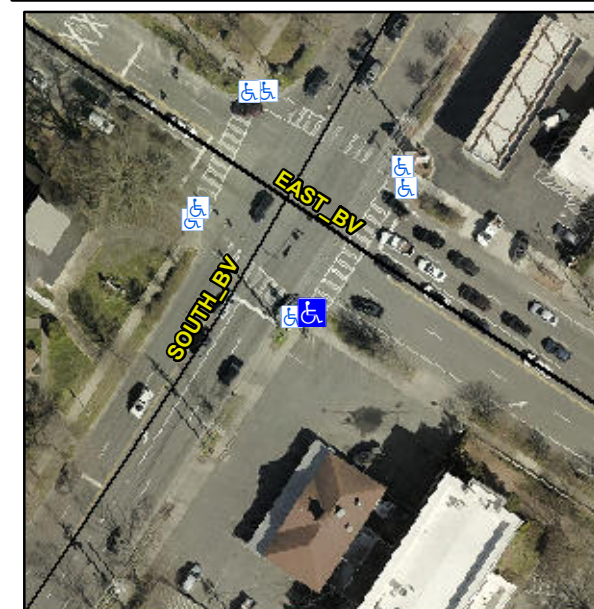
Compliance	Description	Data	Compliance	Description	Data
N/A	Ramp Length (in)	54.0	Yes	Ramp Slope (%)	7.2
No	Ramp Width (in)	44.0	Yes	Ramp XSlope (%)	0.9
N/A	Flare Type LT	N/A	N/A	Flare Type RT	N/A
N/A	Flare Slope LT (%)	N/A	N/A	Flare Slope RT (%)	N/A
N/A	Flare Traversable LT?	N/A	N/A	Flare Traversable RT?	N/A
N/A	Landing Length (in)	N/A	N/A	DWS Provided?	N/A
N/A	Landing Width (in)	N/A	N/A	DWS Contrast?	N/A
N/A	Landing Slope (%)	N/A	N/A	DWS Length (in)	N/A
N/A	Landing X Slope (%)	N/A	N/A	DWS Full Width?	N/A
N/A	Landing Curb? (Y/N)	N/A	N/A	DWS Offset (in)	N/A
N/A	Shared Landing?	N/A			
N/A	Gutter Ponding?	N/A	N/A	Gutter Slope (%)	N/A
N/A	Gutter Lip Ht (in)	N/A	N/A	Gutter X Slope (%)	N/A
N/A	Painted X Walk1?	Yes	N/A	Painted X Walk2?	N/A
	X Walk 1 Direction	To NE		X Walk 2 Direction	N/A
N/A	X Walk 1 Width (in)	117.0	N/A	X Walk 2 Width (in)	N/A
	X Walk 1 Slope (%)	6.6		X Walk 2 Slope (%)	N/A
	X Walk 1 X Slope (%)	1.5		X Walk 2 X Slope (%)	N/A

N/A	Ramp inside XWalk1?	Yes	N/A	Ramp inside XWalk2?	N/A
	Road Slope (%)	N/A	N/A	Clear Space?	N/A
	Road X Slope (%)	N/A	N/A	Clear Space to XWalk (in)	N/A
N/A	Any Obstructions?	N/A	N/A	Storm Grate/Utility Hazard?	N/A
	Obstruction Type			Storm Grate/Utility Type	
		N/A			N/A
		Yes		Surface Condition? (G/P)	Good

Possible Solutions:

**Remove & Replace Entire Ramp.**

**Not Found, R304.5.1**
