Access Compliance Report

Public Rights-of-Way

(Curb Ramps)

Intersection ID: 7100	Main Street: MOTORSPORTS_LN	Cross Street: STATESVILLE_RD	Location: SW
ADA ID: C7C0C3936E15	Ramp Type: Para	Initial Pass/Fail: Pass	Overall Compliance: No
Codes/Mitigation Info/Possible Solution		Field Measurements/Component Compliance

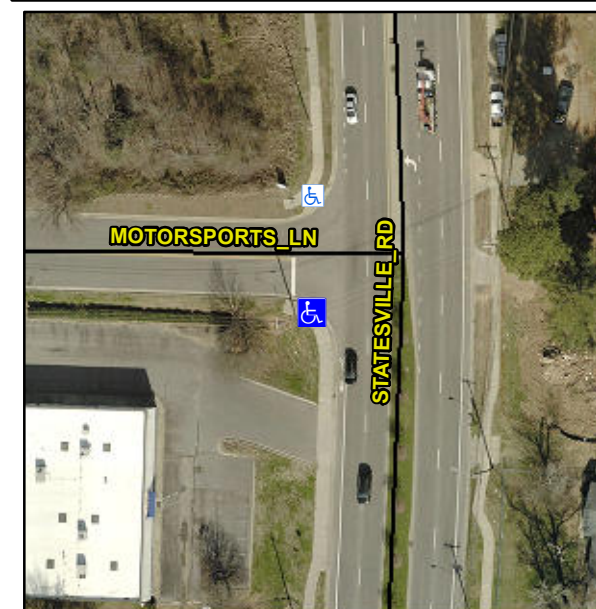
NO RT SW, RT RP < 5%

Compliance	Description	Data	Compliance	Description	Data
N/A	Ramp Length LT (in)	47.0	N/A	Ramp Length RT (in)	50.0
Yes	Ramp Width LT (in)	84.0	Yes	Ramp Width RT (in)	84.0
Yes	Ramp Slope LT (%)	7.9	Yes	Ramp Slope RT (%)	0.3
Yes	Ramp XSlope LT (%)	1.7	Yes	Ramp XSlope RT (%)	0.4
Yes	Landing Length (in)	85.5	Yes	DWS Provided?	Yes
Yes	Landing Width (in)	48.0	Yes	DWS Contrast?	Yes
Yes	Landing Slope (%)	1.2	Yes	DWS Length (in)	24.0
No	Landing X Slope (%)	3.2	Yes	DWS Full Width?	Yes
N/A	Landing Curb? (Y/N)	No	No	DWS Offset (in)	3.0
N/A	Shared Landing?	No			
No	Gutter Ponding?	Yes	No	Gutter Slope (%)	6.7
Yes	Gutter Lip Ht (in)	0.0	No	Gutter X Slope (%)	3.6
N/A	Painted X Walk1?	No	N/A	Painted X Walk2?	N/A
	X Walk 1 Direction	To N		X Walk 2 Direction	N/A
N/A	X Walk 1 Width (in)	N/A	N/A	X Walk 2 Width (in)	N/A
	X Walk 1 Slope (%)	0.7		X Walk 2 Slope (%)	N/A
	X Walk 1 X Slope (%)	4.3		X Walk 2 X Slope (%)	N/A
N/A	Ramp inside XWalk1?	N/A	N/A	Ramp inside XWalk2?	N/A

Road Slope (%)	N/A	N/A	Clear Space?	Yes
	Road X Slope (%)	N/A	N/A	Clear Space to XWalk (in)	N/A
Yes	Any Obstructions?	No	Yes	Storm Grate/Utility Hazard?	No
	Obstruction Type			Storm Grate/Utility Type	
		N/A			N/A
			Yes	Surface Condition? (G/P)	Good
			Compliant	Curb Slope (%)	3.8

Remove & Replace Entire Ramp.
Remove & Replace Gutter.

R304.5.3, R305.2, R302.7, R304.5.4
