Access Compliance Report

Public Rights-of-Way

(Curb Ramps)

Intersection ID: 15599	Main Street: COLVILLE_RD	Cross Street: EASTOVER_RD	Location:	E
ADA ID: C7C5ED7C587D	Ramp Type: Perp	Initial Pass/Fail: Fail	Overall Compliance: No	Severity Score: 25

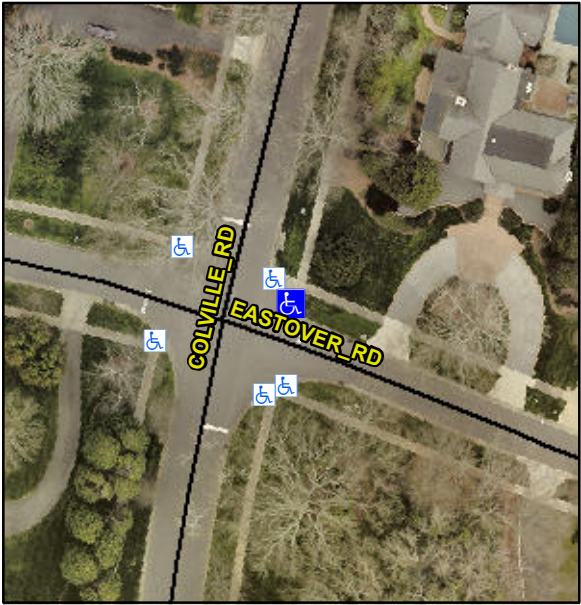
Possible Solutions:		Compliance	Description	Data
	Remove & Replace Entire Ramp.		N/A	Ramp Length (in)	42.0
			Yes	Ramp Width (in)	48.0
			N/A	Flare Type LT	N/A
			N/A	Flare Slope LT (%)	N/A
			N/A	Flare Traversable LT?	N/A
			N/A	Landing Length (in)	N/A
			N/A	Landing Width (in)	N/A
			N/A	Landing Slope (%)	N/A
			N/A	Landing X Slope (%)	N/A
<p>Surveyor Notes:</p> <p>N/A</p> <p>PROW/ADA:</p> <p>Not Found, R304.2.2, R304.5.3</p>			N/A	Flare Type RT	N/A
			N/A	Flare Slope RT (%)	N/A
			N/A	Flare Traversable RT?	N/A
			N/A	DWS Provided?	N/A
			N/A	DWS Contrast?	N/A
			N/A	DWS Length (in)	N/A
			N/A	DWS Full Width?	N/A
			N/A	DWS Offset (in)	N/A
			N/A	Shared Landing?	N/A
			N/A	Gutter Ponding?	N/A
			N/A	Gutter Lip Ht (in)	N/A
			N/A	Painted X Walk1?	No
				X Walk 1 Direction	To SW
			N/A	X Walk 1 Width (in)	N/A
				X Walk 1 Slope (%)	1.1

X Walk 1 X Slope (%)	5.5
			N/A	Ramp inside XWalk1?	N/A
			N/A	Road Slope (%)	N/A
			N/A	Road X Slope (%)	N/A
			N/A	Any Obstructions?	N/A
				Obstruction Type	
Total Cost:		\$ 1850.00			
			N/A		N/A
			Yes	Surface Condition? (G/P)	Good
