# Access Compliance Report

## Public Rights-of-Way

### (Curb Ramps)

Intersection ID: 13408	Main Street: COMMONWEALTH_AV	Cross Street: THE_PLAZA	Location:	N
ADA ID: C7C6BCED3097	Ramp Type: Directional1	Initial Pass/Fail: Pass	Overall Compliance: No	Severity Score: 2.5

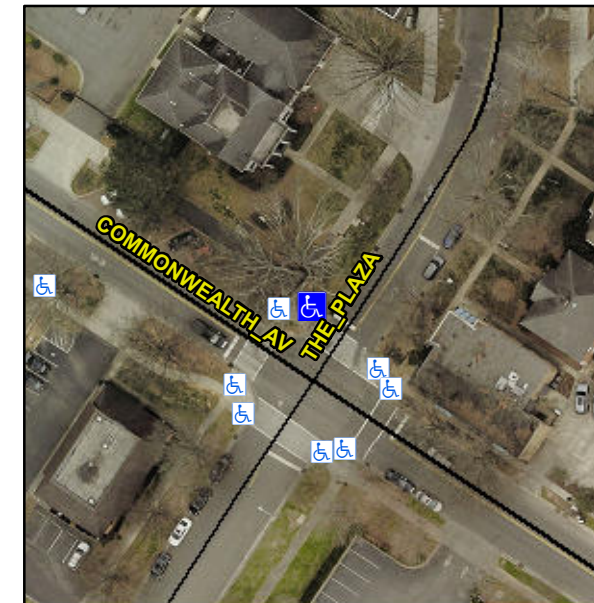
**Not Found, R305.1.4, R305.2**

Compliance	Description	Data	Compliance	Description	Data
N/A	Ramp Length (in)	114.5	Yes	Grade Break?	Yes
Yes	Ramp Width (in)	53.0	Yes	Grade Break Slope (%)	2.4
Yes	Ramp Slope (%)	2.7	Yes	Grade Break XSlope (%)	1.3
Yes	Ramp XSlope (%)	0.9			
Yes	Flare Type LT	N/A	Yes	Flare Type RT	N/A
N/A	Flare Slope LT (%)	N/A	N/A	Flare Slope RT (%)	N/A
N/A	Flare Traversable LT?	No	N/A	Flare Traversable RT?	No
Yes	Landing Length (in)	68.0	Yes	DWS Provided?	Yes
Yes	Landing Width (in)	71.5	Yes	DWS Contrast?	Yes
Yes	Landing Slope (%)	0.2	Yes	DWS Length (in)	24.0
Yes	Landing X Slope (%)	1.0	No	DWS Full Width?	No
N/A	Landing Curb? (Y/N)	No	No	DWS Offset LT (in)	6.5
N/A	Shared Landing?	Yes	Yes	DWS Offset RT (in)	25.5
Yes	Gutter Ponding?	No	Yes	Gutter Slope (%)	0.1
Yes	Gutter Lip Ht (in)	0.0	Yes	Gutter X Slope (%)	0.4
N/A	Painted X Walk1?	Yes		Road Slope (%)	0.2
	X Walk 1 Direction	To SE		Road X Slope (%)	0.0
	X Walk 1 Width (in)	125.0		Clear Space?	Yes

X Walk 1 Slope (%)	0.2	N/A	Clear Space to XWalk (in)	N/A
	X Walk 1 X Slope (%)	0.0	Yes	Storm Grate/Utility Hazard?	No
Yes	Ramp inside XWalk1?	Yes		Storm Grate/Utility Type	
Yes	Any Obstructions?	No			N/A
	Obstruction Type		Yes	Surface Condition? (G/P)	Good
			N/A	Curb Slope (%)	17.6

**Remove & Replace Entire Ramp.**
