Access Compliance Report

Public Rights-of-Way

(Curb Ramps)

Intersection ID: 27341	Main Street: BALLANVILLA_DR	Cross Street: VILLA_TRACE_PL	Location: NE
ADA ID: C7C799EB9FB8	Ramp Type: PerpDiag	Initial Pass/Fail: Fail	Overall Compliance: No
Severity Score: 21.25			
Codes/Mitigation Info/Possible Solution		Field Measurements/Component Compliance

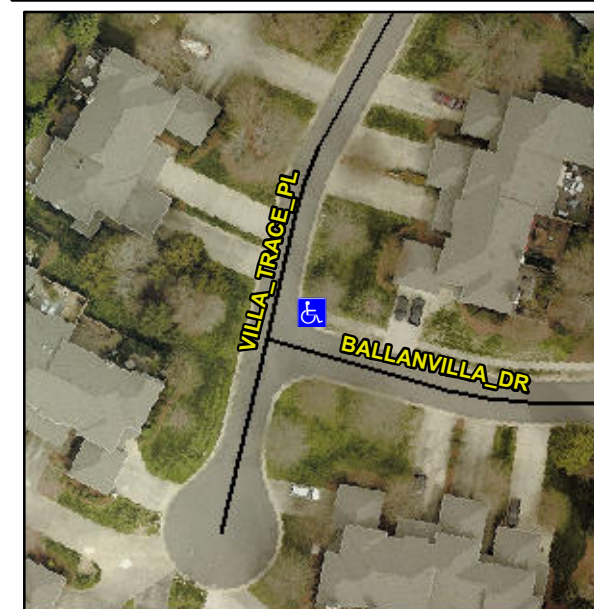
Compliance	Description	Data	Compliance	Description	Data
N/A	Ramp Length (in)	53.0	Yes	Ramp Slope (%)	5.2
No	Ramp Width (in)	45.5	No	Ramp XSlope (%)	6.4
N/A	Flare Type LT	N/A	N/A	Flare Type RT	N/A
N/A	Flare Slope LT (%)	N/A	N/A	Flare Slope RT (%)	N/A
N/A	Flare Traversable LT?	N/A	N/A	Flare Traversable RT?	N/A
N/A	Landing Length (in)	N/A	N/A	DWS Provided?	N/A
N/A	Landing Width (in)	N/A	N/A	DWS Contrast?	N/A
N/A	Landing Slope (%)	N/A	N/A	DWS Length (in)	N/A
N/A	Landing X Slope (%)	N/A	N/A	DWS Full Width?	N/A
N/A	Landing Curb? (Y/N)	N/A	N/A	DWS Offset (in)	N/A
N/A	Shared Landing?	N/A			
N/A	Gutter Ponding?	N/A	N/A	Gutter Slope (%)	N/A
N/A	Gutter Lip Ht (in)	N/A	N/A	Gutter X Slope (%)	N/A
N/A	Painted X Walk1?	No	N/A	Painted X Walk2?	No
	X Walk 1 Direction	To S		X Walk 2 Direction	To W
N/A	X Walk 1 Width (in)	N/A	N/A	X Walk 2 Width (in)	N/A
	X Walk 1 Slope (%)	4.5		X Walk 2 Slope (%)	1.2
	X Walk 1 X Slope (%)	0.1		X Walk 2 X Slope (%)	4.0

N/A	Ramp inside XWalk1?	N/A	N/A	Ramp inside XWalk2?	N/A
	Road Slope (%)	2.2	N/A	Clear Space?	N/A
	Road X Slope (%)	2.7	N/A	Clear Space to XWalk (in)	N/A
N/A	Any Obstructions?	N/A	N/A	Storm Grate/Utility Hazard?	N/A
	Obstruction Type			Storm Grate/Utility Type	
		N/A			N/A
		Yes		Surface Condition? (G/P)	Good

Remove & Replace Curb Ramp With Two New Directional Ramps or Equivalent.

R304.5.1, R304.5.3
