Access Compliance Report

Public Rights-of-Way

(Curb Ramps)

Intersection ID: 11727	Main Street: W_8TH_ST	Cross Street: N_POPLAR_ST	Location:	E
ADA ID: C7C8E095B481	Ramp Type: PerpDiag	Initial Pass/Fail: Fail	Overall Compliance: No	Severity Score: 25

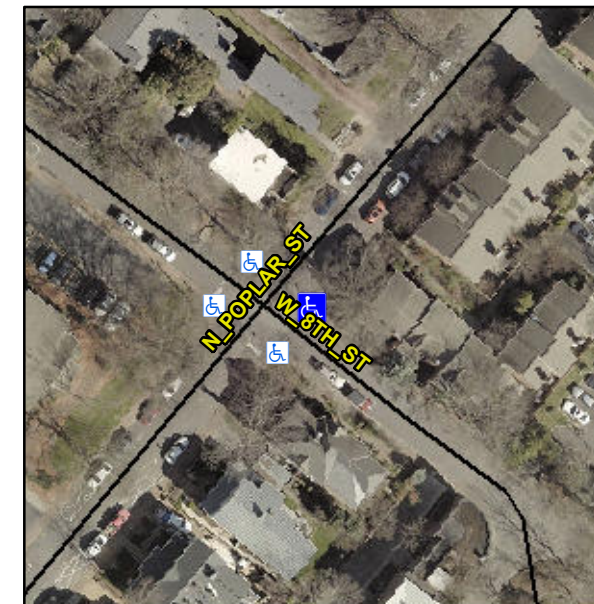
Compliance	Description	Data	Compliance	Description	Data
N/A	Ramp Length (in)	41.0	No	Ramp Slope (%)	12.0
Yes	Ramp Width (in)	48.0	Yes	Ramp XSlope (%)	1.9
N/A	Flare Type LT	N/A	N/A	Flare Type RT	N/A
N/A	Flare Slope LT (%)	N/A	N/A	Flare Slope RT (%)	N/A
N/A	Flare Traversable LT?	N/A	N/A	Flare Traversable RT?	N/A
N/A	Landing Length (in)	N/A	N/A	DWS Provided?	N/A
N/A	Landing Width (in)	N/A	N/A	DWS Contrast?	N/A
N/A	Landing Slope (%)	N/A	N/A	DWS Length (in)	N/A
N/A	Landing X Slope (%)	N/A	N/A	DWS Full Width?	N/A
N/A	Landing Curb? (Y/N)	N/A	N/A	DWS Offset (in)	N/A
N/A	Shared Landing?	N/A			
N/A	Gutter Ponding?	N/A	N/A	Gutter Slope (%)	N/A
N/A	Gutter Lip Ht (in)	N/A	N/A	Gutter X Slope (%)	N/A
N/A	Painted X Walk1?	No	N/A	Painted X Walk2?	No
	X Walk 1 Direction	To NW		X Walk 2 Direction	To SW
N/A	X Walk 1 Width (in)	N/A	N/A	X Walk 2 Width (in)	N/A
	X Walk 1 Slope (%)	4.8		X Walk 2 Slope (%)	2.1
	X Walk 1 X Slope (%)	0.6		X Walk 2 X Slope (%)	6.0

N/A	Ramp inside XWalk1?	N/A	N/A	Ramp inside XWalk2?	N/A
	Road Slope (%)	4.5	N/A	Clear Space?	N/A
	Road X Slope (%)	2.0	N/A	Clear Space to XWalk (in)	N/A
N/A	Any Obstructions?	N/A	N/A	Storm Grate/Utility Hazard?	N/A
	Obstruction Type			Storm Grate/Utility Type	
		N/A			N/A
			Yes	Surface Condition? (G/P)	Good

Remove & Replace Curb Ramp With Two New Directional Ramps or Equivalent.
