# Access Compliance Report

## Public Rights-of-Way

### (Curb Ramps)

Intersection ID: 21323	Main Street: STARBROOK_DR	Cross Street: WOODSTREAM_DR	Location: SW
ADA ID: C7CF2886F877	Ramp Type: PerpDiag	Initial Pass/Fail: Fail	Overall Compliance: No
		Severity Score: 8.75

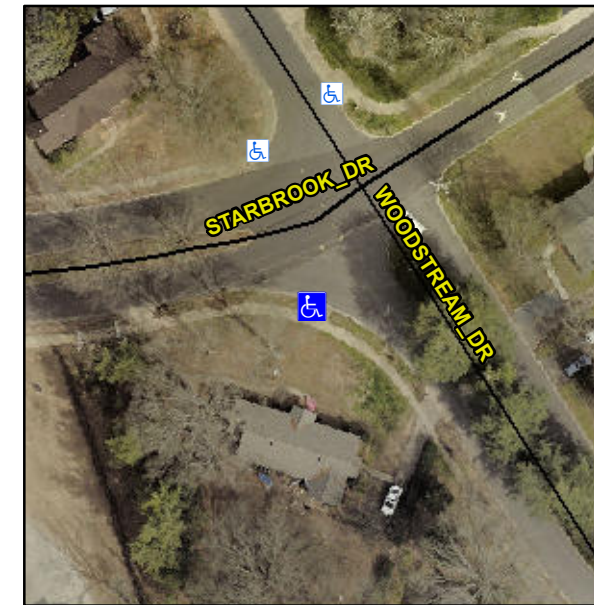
Compliance	Description	Data	Compliance	Description	Data
N/A	Ramp Length (in)	72.0	Yes	Ramp Slope (%)	6.2
No	Ramp Width (in)	47.0	Yes	Ramp XSlope (%)	0.3
N/A	Flare Type LT	N/A	N/A	Flare Type RT	N/A
N/A	Flare Slope LT (%)	N/A	N/A	Flare Slope RT (%)	N/A
N/A	Flare Traversable LT?	N/A	N/A	Flare Traversable RT?	N/A
N/A	Landing Length (in)	N/A	N/A	DWS Provided?	N/A
N/A	Landing Width (in)	N/A	N/A	DWS Contrast?	N/A
N/A	Landing Slope (%)	N/A	N/A	DWS Length (in)	N/A
N/A	Landing X Slope (%)	N/A	N/A	DWS Full Width?	N/A
N/A	Landing Curb? (Y/N)	N/A	N/A	DWS Offset (in)	N/A
N/A	Shared Landing?	N/A			
N/A	Gutter Ponding?	N/A	N/A	Gutter Slope (%)	N/A
N/A	Gutter Lip Ht (in)	N/A	N/A	Gutter X Slope (%)	N/A
N/A	Painted X Walk1?	No	N/A	Painted X Walk2?	No
	X Walk 1 Direction	To NE		X Walk 2 Direction	To N
N/A	X Walk 1 Width (in)	N/A	N/A	X Walk 2 Width (in)	N/A
	X Walk 1 Slope (%)	1.5		X Walk 2 Slope (%)	0.8
	X Walk 1 X Slope (%)	0.7		X Walk 2 X Slope (%)	0.9

N/A	Ramp inside XWalk1?	N/A	N/A	Ramp inside XWalk2?	N/A
	Road Slope (%)	1.3	N/A	Clear Space?	N/A
	Road X Slope (%)	1.1	N/A	Clear Space to XWalk (in)	N/A
N/A	Any Obstructions?	N/A	N/A	Storm Grate/Utility Hazard?	N/A
	Obstruction Type			Storm Grate/Utility Type	
		N/A			N/A
			Yes	Surface Condition? (G/P)	Good

**Remove & Replace Curb Ramp With Two New Directional Ramps or Equivalent.**

**R304.5.1**
