Access Compliance Report

Public Rights-of-Way

(Curb Ramps)

Intersection ID: N/A	Main Street: BROOKSVALE_ST	Cross Street: BURNETTE_AV	Location: NE
ADA ID: C7D0604A5A6B	Ramp Type: Perp	Initial Pass/Fail: Fail	Overall Compliance: No
		Severity Score: 12.5

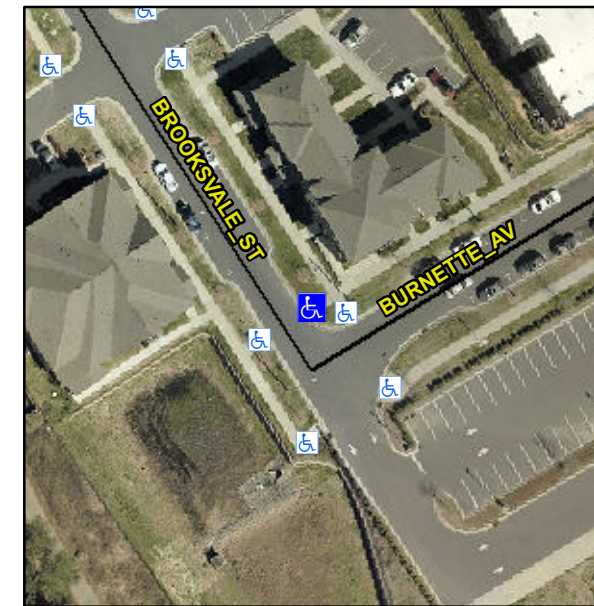
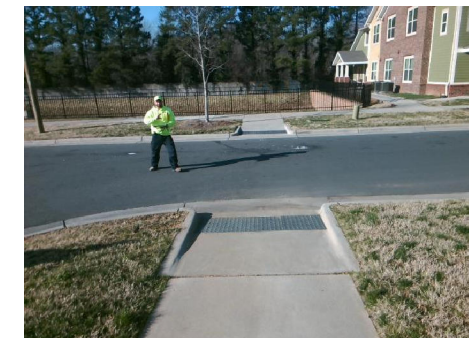
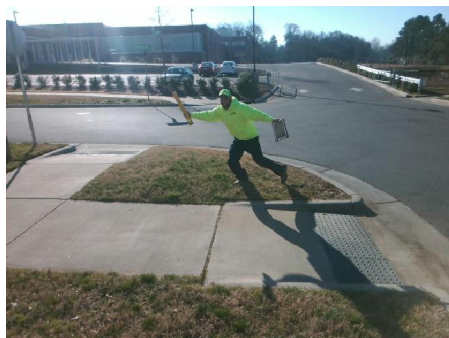
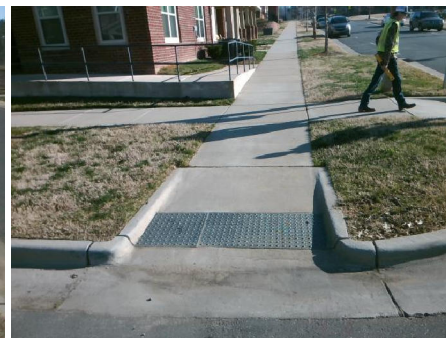
Not Found, R304.2.2

Compliance	Description	Data	Compliance	Description	Data
N/A	Ramp Length (in)	73.0	No	Ramp Slope (%)	8.6
Yes	Ramp Width (in)	70.0	Yes	Ramp XSlope (%)	0.1
N/A	Flare Type LT	N/A	N/A	Flare Type RT	N/A
N/A	Flare Slope LT (%)	N/A	N/A	Flare Slope RT (%)	N/A
N/A	Flare Traversable LT?	N/A	N/A	Flare Traversable RT?	N/A
N/A	Landing Length (in)	N/A	N/A	DWS Provided?	N/A
N/A	Landing Width (in)	N/A	N/A	DWS Contrast?	N/A
N/A	Landing Slope (%)	N/A	N/A	DWS Length (in)	N/A
N/A	Landing X Slope (%)	N/A	N/A	DWS Full Width?	N/A
N/A	Landing Curb? (Y/N)	N/A	N/A	DWS Offset (in)	N/A
N/A	Shared Landing?	N/A			
N/A	Gutter Ponding?	N/A	N/A	Gutter Slope (%)	N/A
N/A	Gutter Lip Ht (in)	N/A	N/A	Gutter X Slope (%)	N/A
N/A	Painted X Walk1?	No	N/A	Painted X Walk2?	N/A
	X Walk 1 Direction	To SW		X Walk 2 Direction	N/A
N/A	X Walk 1 Width (in)	N/A	N/A	X Walk 2 Width (in)	N/A
	X Walk 1 Slope (%)	0.8		X Walk 2 Slope (%)	N/A
	X Walk 1 X Slope (%)	0.2		X Walk 2 X Slope (%)	N/A

N/A	Ramp inside XWalk1?	N/A	N/A	Ramp inside XWalk2?	N/A
	Road Slope (%)	N/A	N/A	Clear Space?	N/A
	Road X Slope (%)	N/A	N/A	Clear Space to XWalk (in)	N/A
N/A	Any Obstructions?	N/A	N/A	Storm Grate/Utility Hazard?	N/A
	Obstruction Type			Storm Grate/Utility Type	
		N/A			N/A
			Yes	Surface Condition? (G/P)	Good

Remove & Replace Entire Ramp.
