# Access Compliance Report

## Public Rights-of-Way

### (Curb Ramps)

| Intersection ID: 47449 | Main Street: MALLARD_LANDING_RD | Cross Street: WOOD_DUCK_CROSSING_DR | Location: SW |

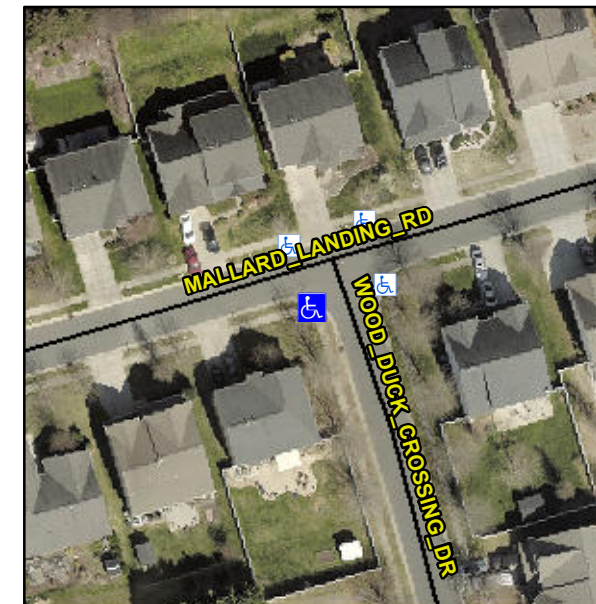
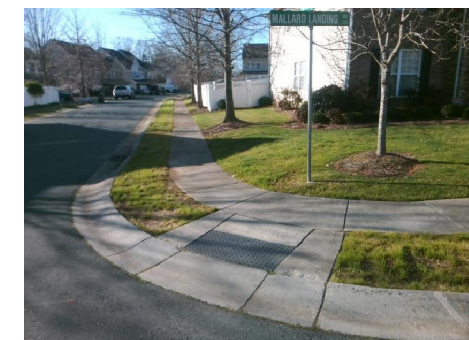
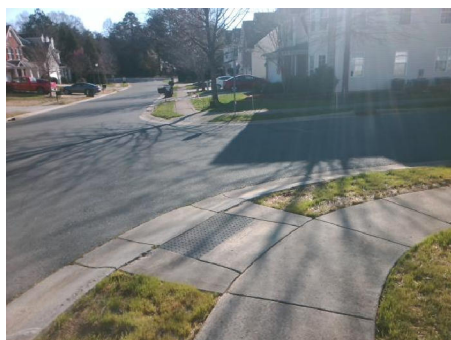
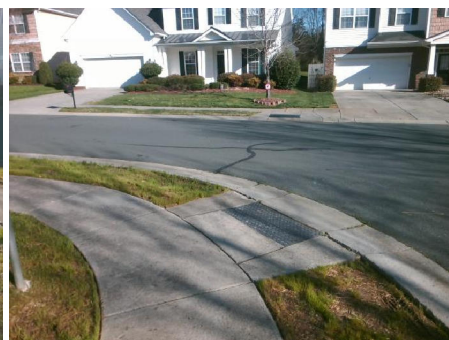
**R304.2.1, R304.2.2-Perp, R304.3.2-Para, R304.5.3**

| Compliance | Description | Data | Compliance | Description | Data |
|---|---|---|---|---|---|
| No | Landing Length (in) | 46.5 | Yes | DWS Provided? | Yes |
| No | Landing Slope (%) | 5.4 | Yes | DWS Length (in) | 24.0 |
| No | Landing X Slope (%) | 4.3 | Yes | DWS Full Width? | Yes |

**Remove & Replace Landing.**

Total Cost: \$ 500.00
