Intersection ID: 28857	Main Street: KAVAN_HUNTER_DR	Cross Street: SULLINS_RD	Location:	W
ADA ID: C7E2B0FEE955	Ramp Type: Perp	Initial Pass/Fail: Fail	Overall Compliance: No	Severity Score: 22.5

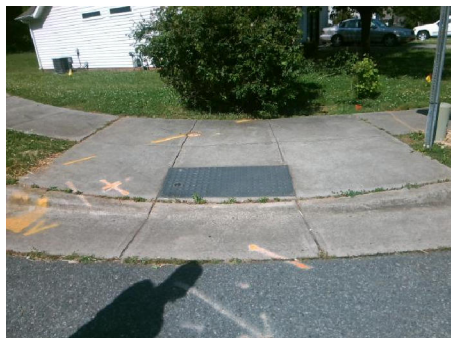
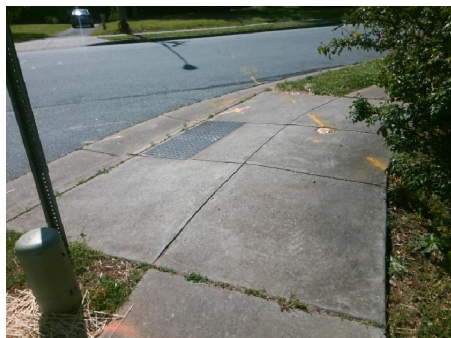
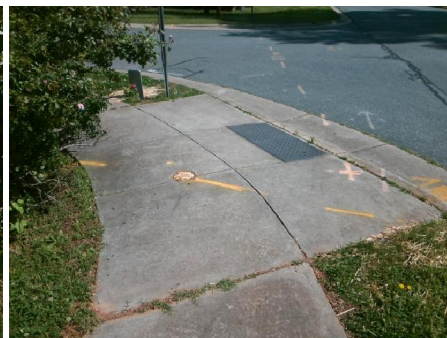
Codes/Mitigation Info/Possible Solution			Field Measurements/Component Compliance					
	Possible Solutions:		Compliance	Description	Data	Compliance	Description	Data
	Remove & Replace Entire Ramp.		N/A	Ramp Length (in)	51.0	No	Ramp Slope (%)	9.0
			No	Ramp Width (in)	44.5	No	Ramp XSlope (%)	4.1
			N/A	Flare Type LT	N/A	N/A	Flare Type RT	N/A
			N/A	Flare Slope LT (%)	N/A	N/A	Flare Slope RT (%)	N/A
			N/A	Flare Traversable LT?	N/A	N/A	Flare Traversable RT?	N/A
			N/A	Landing Length (in)	N/A	N/A	DWS Provided?	N/A
			N/A	Landing Width (in)	N/A	N/A	DWS Contrast?	N/A
			N/A	Landing Slope (%)	N/A	N/A	DWS Length (in)	N/A
			N/A	Landing X Slope (%)	N/A	N/A	DWS Full Width?	N/A
Surveyor Notes:			N/A	Landing Curb? (Y/N)	N/A	N/A	DWS Offset (in)	N/A
		N/A		Shared Landing?	N/A			
PROW/ADA:			N/A	Gutter Ponding?	N/A	N/A	Gutter Slope (%)	N/A
		Not Found, R304.5.1, R304.2.2, R304.5.3	N/A	Gutter Lip Ht (in)	N/A	N/A	Gutter X Slope (%)	N/A

N/A	Painted X Walk1?	No	N/A	Painted X Walk2?	N/A
				X Walk 1 Direction	To E		X Walk 2 Direction	N/A
			N/A	X Walk 1 Width (in)	N/A	N/A	X Walk 2 Width (in)	N/A
				X Walk 1 Slope (%)	5.8		X Walk 2 Slope (%)	N/A
				X Walk 1 X Slope (%)	3.4		X Walk 2 X Slope (%)	N/A
			N/A	Ramp inside XWalk1?	N/A	N/A	Ramp inside XWalk2?	N/A
				Road Slope (%)	N/A	N/A	Clear Space?	N/A
				Road X Slope (%)	N/A	N/A	Clear Space to XWalk (in)	N/A
			N/A	Any Obstructions?	N/A	N/A	Storm Grate/Utility Hazard?	N/A
				Obstruction Type			Storm Grate/Utility Type	
					N/A			N/A
						Yes	Surface Condition? (G/P)	Good
Total Cost:		\$ 1850.00
