Access Compliance Report

Public Rights-of-Way

(Curb Ramps)

Intersection ID: 20146	Main Street: FAIRVIEW_RD	Cross Street: PARK_SOUTH_DR	Location: SW
ADA ID: C7E30C7288B2	Ramp Type: Para	Initial Pass/Fail: Fail	Overall Compliance: No
Severity Score: 13.75			
Codes/Mitigation Info/Possible Solution		Field Measurements/Component Compliance

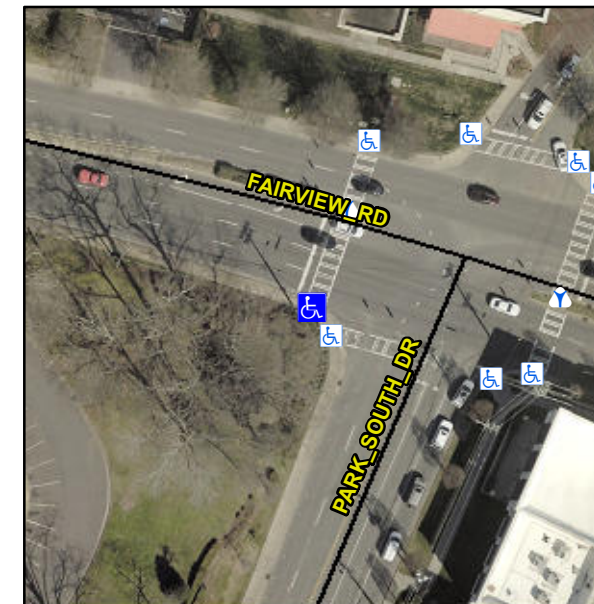
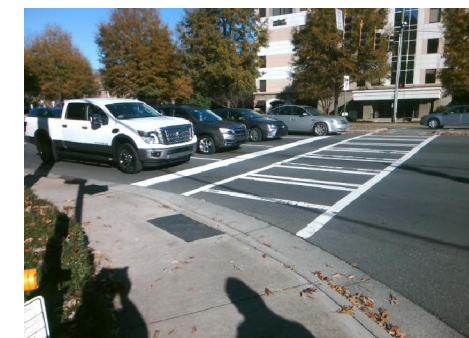
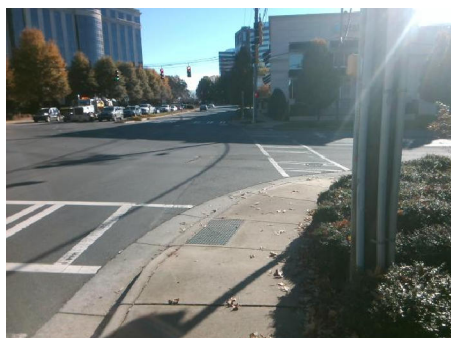
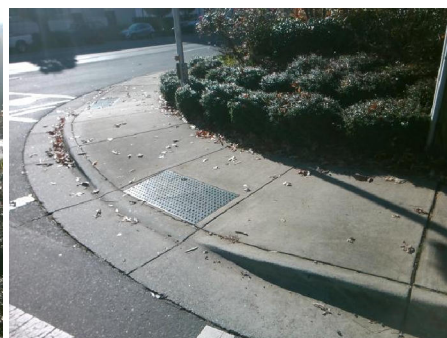
LT RP < 5%

Compliance	Description	Data	Compliance	Description	Data
N/A	Ramp Length LT (in)	60.0	N/A	Ramp Length RT (in)	58.0
Yes	Ramp Width LT (in)	70.0	Yes	Ramp Width RT (in)	70.0
Yes	Ramp Slope LT (%)	1.0	No	Ramp Slope RT (%)	10.8
Yes	Ramp XSlope LT (%)	1.8	No	Ramp XSlope RT (%)	3.4
N/A	Landing Length (in)	N/A	N/A	DWS Provided?	N/A
N/A	Landing Width (in)	N/A	N/A	DWS Contrast?	N/A
N/A	Landing Slope (%)	N/A	N/A	DWS Length (in)	N/A
N/A	Landing X Slope (%)	N/A	N/A	DWS Full Width?	N/A
N/A	Landing Curb? (Y/N)	N/A	N/A	DWS Offset (in)	N/A
N/A	Shared Landing?	N/A			
N/A	Gutter Ponding?	N/A	N/A	Gutter Slope (%)	N/A
N/A	Gutter Lip Ht (in)	N/A	N/A	Gutter X Slope (%)	N/A
N/A	Painted X Walk1?	Yes	N/A	Painted X Walk2?	N/A
	X Walk 1 Direction	To NE		X Walk 2 Direction	N/A
N/A	X Walk 1 Width (in)	109.0	N/A	X Walk 2 Width (in)	N/A
	X Walk 1 Slope (%)	4.9		X Walk 2 Slope (%)	N/A
	X Walk 1 X Slope (%)	1.0		X Walk 2 X Slope (%)	N/A
N/A	Ramp inside XWalk1?	Yes	N/A	Ramp inside XWalk2?	N/A

Road Slope (%)	N/A	N/A	Clear Space?	N/A
	Road X Slope (%)	N/A	N/A	Clear Space to XWalk (in)	N/A
N/A	Any Obstructions?	N/A	N/A	Storm Grate/Utility Hazard?	N/A
	Obstruction Type			Storm Grate/Utility Type	
		N/A			N/A
			Yes	Surface Condition? (G/P)	Good
			N/A	Curb Slope (%)	0.5

Possible Solutions:

Remove & Replace Entire Ramp.

R304.3.2, R304.5.3
