Access Compliance Report

Public Rights-of-Way

(Curb Ramps)

Intersection ID: 10015694	Main Street: IKEA_BV	Cross Street: N/A	Location: SW
ADA ID: C7FD53BED31C	Ramp Type: Perp	Initial Pass/Fail: Fail	Overall Compliance: No
Severity Score: 13.75			
Codes/Mitigation Info/Possible Solution		Field Measurements/Component Compliance

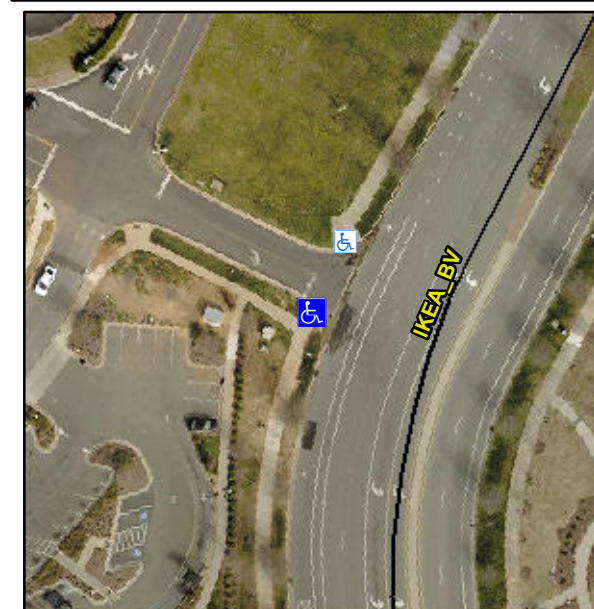
R304.2.2, R304.5.3

Compliance	Description	Data	Compliance	Description	Data
N/A	Ramp Length (in)	104.0	No	Ramp Slope (%)	9.1
Yes	Ramp Width (in)	48.0	No	Ramp XSlope (%)	3.2
N/A	Flare Type LT	N/A	N/A	Flare Type RT	N/A
N/A	Flare Slope LT (%)	N/A	N/A	Flare Slope RT (%)	N/A
N/A	Flare Traversable LT?	N/A	N/A	Flare Traversable RT?	N/A
N/A	Landing Length (in)	N/A	N/A	DWS Provided?	N/A
N/A	Landing Width (in)	N/A	N/A	DWS Contrast?	N/A
N/A	Landing Slope (%)	N/A	N/A	DWS Length (in)	N/A
N/A	Landing X Slope (%)	N/A	N/A	DWS Full Width?	N/A
N/A	Landing Curb? (Y/N)	N/A	N/A	DWS Offset (in)	N/A
N/A	Shared Landing?	N/A			
N/A	Gutter Ponding?	N/A	N/A	Gutter Slope (%)	N/A
N/A	Gutter Lip Ht (in)	N/A	N/A	Gutter X Slope (%)	N/A
N/A	Painted X Walk1?	No	N/A	Painted X Walk2?	N/A
	X Walk 1 Direction	To N		X Walk 2 Direction	N/A
N/A	X Walk 1 Width (in)	N/A	N/A	X Walk 2 Width (in)	N/A
	X Walk 1 Slope (%)	0.1		X Walk 2 Slope (%)	N/A
	X Walk 1 X Slope (%)	1.2		X Walk 2 X Slope (%)	N/A

N/A	Ramp inside XWalk1?	N/A	N/A	Ramp inside XWalk2?	N/A
	Road Slope (%)	N/A	N/A	Clear Space?	N/A
	Road X Slope (%)	N/A	N/A	Clear Space to XWalk (in)	N/A
N/A	Any Obstructions?	N/A	N/A	Storm Grate/Utility Hazard?	N/A
	Obstruction Type			Storm Grate/Utility Type	
		N/A			N/A
			Yes	Surface Condition? (G/P)	Good

Possible Solutions:

Remove & Replace Entire Ramp.
