Access Compliance Report

Public Rights-of-Way

(Curb Ramps)

Intersection ID: 10020687	Main Street: BEAM_RD	Cross Street: N/A	Location: NW
ADA ID: C80799DC5087	Ramp Type: Perp	Initial Pass/Fail: Fail	Overall Compliance: No
Severity Score: 12.5			
Codes/Mitigation Info/Possible Solution		Field Measurements/Component Compliance

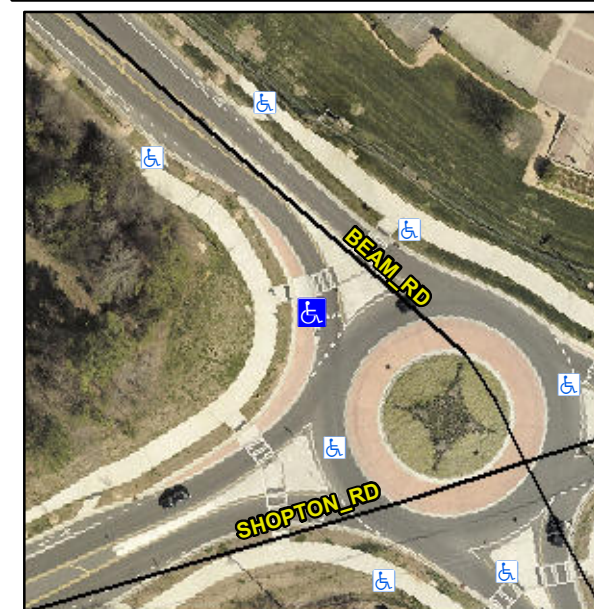
Compliance	Description	Data	Compliance	Description	Data
N/A	Ramp Length (in)	226.0	Yes	Ramp Slope (%)	9.5
Yes	Ramp Width (in)	98.0	Yes	Ramp XSlope (%)	1.2
N/A	Flare Type LT	N/A	N/A	Flare Type RT	N/A
N/A	Flare Slope LT (%)	N/A	N/A	Flare Slope RT (%)	N/A
N/A	Flare Traversable LT?	N/A	N/A	Flare Traversable RT?	N/A
N/A	Landing Length (in)	N/A	N/A	DWS Provided?	N/A
N/A	Landing Width (in)	N/A	N/A	DWS Contrast?	N/A
N/A	Landing Slope (%)	N/A	N/A	DWS Length (in)	N/A
N/A	Landing X Slope (%)	N/A	N/A	DWS Full Width?	N/A
N/A	Landing Curb? (Y/N)	N/A	N/A	DWS Offset (in)	N/A
N/A	Shared Landing?	N/A			
N/A	Gutter Ponding?	N/A	N/A	Gutter Slope (%)	N/A
N/A	Gutter Lip Ht (in)	N/A	N/A	Gutter X Slope (%)	N/A
N/A	Painted X Walk1?	Yes	N/A	Painted X Walk2?	N/A
	X Walk 1 Direction	To E		X Walk 2 Direction	N/A
N/A	X Walk 1 Width (in)	112.0	N/A	X Walk 2 Width (in)	N/A
	X Walk 1 Slope (%)	1.8		X Walk 2 Slope (%)	N/A
	X Walk 1 X Slope (%)	2.5		X Walk 2 X Slope (%)	N/A

N/A	Ramp inside XWalk1?	Yes	N/A	Ramp inside XWalk2?	N/A
	Road Slope (%)	N/A	N/A	Clear Space?	N/A
	Road X Slope (%)	N/A	N/A	Clear Space to XWalk (in)	N/A
N/A	Any Obstructions?	N/A	N/A	Storm Grate/Utility Hazard?	N/A
	Obstruction Type			Storm Grate/Utility Type	
		N/A			N/A
		Yes		Surface Condition? (G/P)	Good

Possible Solutions:

Remove & Replace Entire Ramp.
