## Access Compliance Report Public Rights-of-Way (Curb Ramps)

Intersection ID: 52622 Main Street: HERITAGE\_POND\_DR Cross Street: ALEXANDER\_COMMONS\_DR Location: S

ADA ID: C80815155C5D Ramp Type: Perp Initial Pass/Fail: Fail Overall Compliance: No Severity Score: 25

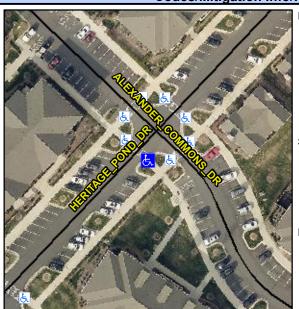
Field Measurements/Component Compliance								
Compliance Description		Data	Comp	liance Description	Data			
N/A	Ramp Length (in)	97.5	No	Ramp Slope (%)	18.7			
Yes	Ramp Width (in)	87.0	Yes	Ramp XSlope (%)	1.1			
N/A	Flare Type LT	N/A	N/A	Flare Type RT	N/A			
N/A	Flare Slope LT (%)	N/A	N/A	Flare Slope RT (%)	N/A			
N/A	Flare Traversable LT?	N/A	N/A	Flare Traversable RT?	N/A			
N/A	Landing Length (in)	N/A	N/A	DWS Provided?	N/A			
N/A	Landing Width (in)	N/A	N/A	DWS Contrast?	N/A			
N/A	Landing Slope (%)	N/A	N/A	DWS Length (in)	N/A			
N/A	Landing X Slope (%)	N/A	N/A	DWS Full Width?	N/A			
N/A	Landing Curb? (Y/N)	N/A	N/A	DWS Offset (in)	N/A			
N/A	Shared Landing?	N/A						
N/A	Gutter Ponding?	N/A	N/A	Gutter Slope (%)	N/A			
N/A	Gutter Lip Ht (in)	N/A	N/A	Gutter X Slope (%)	N/A			
N/A	Painted X Walk1?	Yes	N/A	Painted X Walk2?	N/A			
	X Walk 1 Direction	To NW		X Walk 2 Direction	N/A			
N/A	X Walk 1 Width (in)	86.0	N/A	X Walk 2 Width (in)	N/A

"	1 Caarbie Colution
1000	Possible Solutions:
	Remove & Replace Entire Ramp.
ŝ	
2	
	Surveyor Notes:
	N/A
4	
í	PROW/ADA:
	R304.2.2
N. C
