Access Compliance Report

Public Rights-of-Way

(Curb Ramps)

Intersection ID: 13667	Main Street: E_7TH_ST	Cross Street: HAWTHORNE_LN	Location: W
ADA ID: C80823D6466F	Ramp Type: Perp	Initial Pass/Fail: Fail	Overall Compliance: No
		Severity Score: 12.5

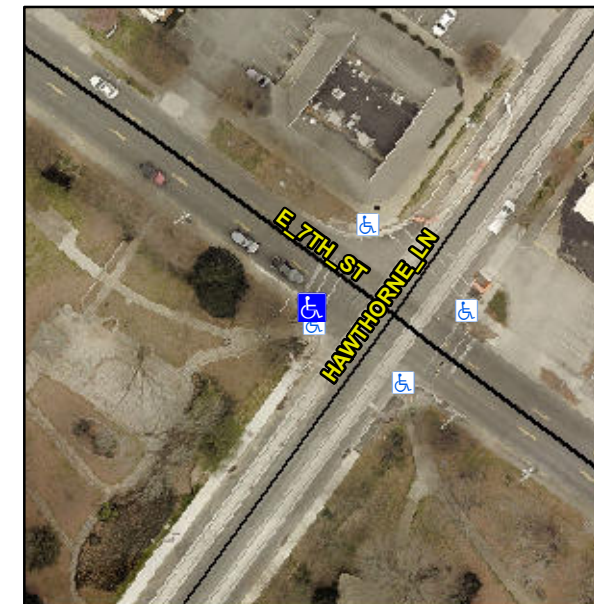
Not Found, R304.2.2

Compliance	Description	Data	Compliance	Description	Data
N/A	Ramp Length (in)	72.0	No	Ramp Slope (%)	9.1
Yes	Ramp Width (in)	48.0	Yes	Ramp XSlope (%)	1.0
N/A	Flare Type LT	N/A	N/A	Flare Type RT	N/A
N/A	Flare Slope LT (%)	N/A	N/A	Flare Slope RT (%)	N/A
N/A	Flare Traversable LT?	N/A	N/A	Flare Traversable RT?	N/A
N/A	Landing Length (in)	N/A	N/A	DWS Provided?	N/A
N/A	Landing Width (in)	N/A	N/A	DWS Contrast?	N/A
N/A	Landing Slope (%)	N/A	N/A	DWS Length (in)	N/A
N/A	Landing X Slope (%)	N/A	N/A	DWS Full Width?	N/A
N/A	Landing Curb? (Y/N)	N/A	N/A	DWS Offset (in)	N/A
N/A	Shared Landing?	N/A			
N/A	Gutter Ponding?	N/A	N/A	Gutter Slope (%)	N/A
N/A	Gutter Lip Ht (in)	N/A	N/A	Gutter X Slope (%)	N/A
N/A	Painted X Walk1?	Yes	N/A	Painted X Walk2?	N/A
	X Walk 1 Direction	To NE		X Walk 2 Direction	N/A
N/A	X Walk 1 Width (in)	110.0	N/A	X Walk 2 Width (in)	N/A
	X Walk 1 Slope (%)	1.6		X Walk 2 Slope (%)	N/A
	X Walk 1 X Slope (%)	1.1		X Walk 2 X Slope (%)	N/A

N/A	Ramp inside XWalk1?	Yes	N/A	Ramp inside XWalk2?	N/A
	Road Slope (%)	N/A	N/A	Clear Space?	N/A
	Road X Slope (%)	N/A	N/A	Clear Space to XWalk (in)	N/A
N/A	Any Obstructions?	N/A	N/A	Storm Grate/Utility Hazard?	N/A
	Obstruction Type			Storm Grate/Utility Type	
		N/A			N/A
			Yes	Surface Condition? (G/P)	Good

Remove & Replace Entire Ramp.

Total Cost: \$ 1850.00
