Access Compliance Report

Public Rights-of-Way

(Curb Ramps)

Intersection ID: 5976	Main Street: MOUNT_HOLLY_RD	Cross Street: CHATTAROY_DR	Location:	N
ADA ID: C808B09623D9	Ramp Type: Perp	Initial Pass/Fail: Fail	Overall Compliance: No	Severity Score: 12.5
Codes/Mitigation Info/Possible Solution		Field Measurements/Component Compliance

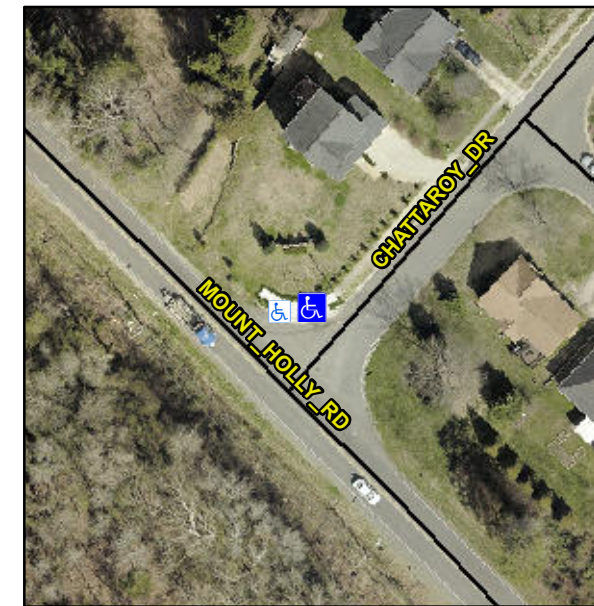
Not Found, R304.2.2

Compliance	Description	Data	Compliance	Description	Data
N/A	Ramp Length (in)	48.0	No	Ramp Slope (%)	11.1
Yes	Ramp Width (in)	48.0	Yes	Ramp XSlope (%)	1.9
N/A	Flare Type LT	N/A	N/A	Flare Type RT	N/A
N/A	Flare Slope LT (%)	N/A	N/A	Flare Slope RT (%)	N/A
N/A	Flare Traversable LT?	N/A	N/A	Flare Traversable RT?	N/A
N/A	Landing Length (in)	N/A	N/A	DWS Provided?	N/A
N/A	Landing Width (in)	N/A	N/A	DWS Contrast?	N/A
N/A	Landing Slope (%)	N/A	N/A	DWS Length (in)	N/A
N/A	Landing X Slope (%)	N/A	N/A	DWS Full Width?	N/A
N/A	Landing Curb? (Y/N)	N/A	N/A	DWS Offset (in)	N/A
N/A	Shared Landing?	N/A			
N/A	Gutter Ponding?	N/A	N/A	Gutter Slope (%)	N/A
N/A	Gutter Lip Ht (in)	N/A	N/A	Gutter X Slope (%)	N/A
N/A	Painted X Walk1?	No	N/A	Painted X Walk2?	N/A
	X Walk 1 Direction	To SE		X Walk 2 Direction	N/A
N/A	X Walk 1 Width (in)	N/A	N/A	X Walk 2 Width (in)	N/A
	X Walk 1 Slope (%)	5.2		X Walk 2 Slope (%)	N/A
	X Walk 1 X Slope (%)	2.7		X Walk 2 X Slope (%)	N/A

Remove & Replace Entire Ramp.
