## Access Compliance Report Public Rights-of-Way (Curb Ramps)

Intersection ID: 10041631Main Street: WHITEHALL\_PARK\_DRCross Street: N/ALocation:NEADA ID: C80AED1FB0F2Ramp Type: BlendTrans2Initial Pass/Fail: FailOverall Compliance: NoSeverity Score: 12.5

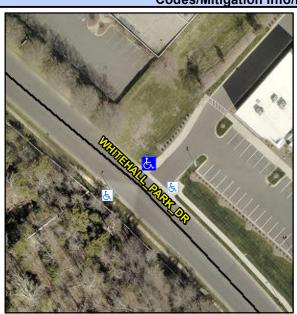
3.3	X Walk 2 Slope (%)		1.0	X Walk 1 Slope (%)	
0.4	X Walk 2 X Slope (%)		0.2	X Walk 1 X Slope (%)	
N/A	Ramp inside XWalk2?	N/A	N/A	Ramp inside XWalk1?	N/A
N/A	Clear Space?		2.7	Road Slope (%)	
N/A	Clear Space to XWalk (in)	N/A	0.2	Road X Slope (%)	
N/A	Storm Grate/Utility Hazard?	N/A	N/A	Any Obstructions?	N/A
	Storm Grate/Utility Type			Obstruction Type	
N/A			N/A		
Good	Surface Condition? (G/P)	Yes

Remove & Replace Curb Ramp With Two New Directional Ramps or Equivalent.

R304.5.3
