Access Compliance Report

Public Rights-of-Way

(Curb Ramps)

Intersection ID: 25656	Main Street: LITTLE_AV	Cross Street: MCMAHAN_DR	Location: SW
ADA ID: C80BDEA3CBA2	Ramp Type: PerpDiag	Initial Pass/Fail: Fail	Overall Compliance: No
Severity Score: 13.75			
Codes/Mitigation Info/Possible Solution		Field Measurements/Component Compliance

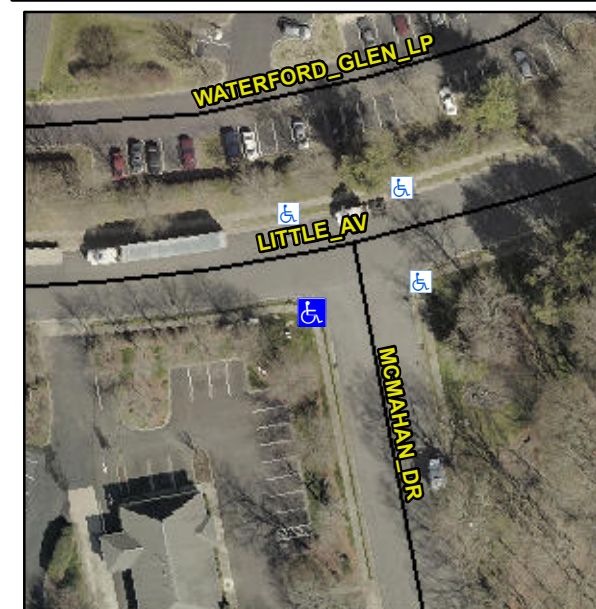
Not Found, R304.2.2, R304.5.3

Compliance	Description	Data	Compliance	Description	Data
N/A	Ramp Length (in)	73.0	No	Ramp Slope (%)	9.6
Yes	Ramp Width (in)	69.0	No	Ramp XSlope (%)	4.1
N/A	Flare Type LT	N/A	N/A	Flare Type RT	N/A
N/A	Flare Slope LT (%)	N/A	N/A	Flare Slope RT (%)	N/A
N/A	Flare Traversable LT?	N/A	N/A	Flare Traversable RT?	N/A
N/A	Landing Length (in)	N/A	N/A	DWS Provided?	N/A
N/A	Landing Width (in)	N/A	N/A	DWS Contrast?	N/A
N/A	Landing Slope (%)	N/A	N/A	DWS Length (in)	N/A
N/A	Landing X Slope (%)	N/A	N/A	DWS Full Width?	N/A
N/A	Landing Curb? (Y/N)	N/A	N/A	DWS Offset (in)	N/A
N/A	Shared Landing?	N/A			
N/A	Gutter Ponding?	N/A	N/A	Gutter Slope (%)	N/A
N/A	Gutter Lip Ht (in)	N/A	N/A	Gutter X Slope (%)	N/A
N/A	Painted X Walk1?	No	N/A	Painted X Walk2?	No
	X Walk 1 Direction	To E		X Walk 2 Direction	To N
N/A	X Walk 1 Width (in)	N/A	N/A	X Walk 2 Width (in)	N/A
	X Walk 1 Slope (%)	6.8		X Walk 2 Slope (%)	2.2
	X Walk 1 X Slope (%)	0.8		X Walk 2 X Slope (%)	7.9

N/A	Ramp inside XWalk1?	N/A	N/A	Ramp inside XWalk2?	N/A
	Road Slope (%)	5.6	N/A	Clear Space?	N/A
	Road X Slope (%)	7.7	N/A	Clear Space to XWalk (in)	N/A
N/A	Any Obstructions?	N/A	N/A	Storm Grate/Utility Hazard?	N/A
	Obstruction Type			Storm Grate/Utility Type	
		N/A			N/A
		Yes		Surface Condition? (G/P)	Good

Possible Solutions:

Remove & Replace Curb Ramp With Two New Directional Ramps or Equivalent.
