Access Compliance Report

Public Rights-of-Way (Curb Ramps)

Intersection ID: 22508	Main Street: KRISLYN_WOODS_PL	Cross Street: SEASCAPE_LN	Location: SE
ADA ID: C80EDA4147AC	Ramp Type: Directional	Initial Pass/Fail: Fail	Overall Compliance: No
Severity Score: 21.25			
Codes/Mitigation Info/Possible Solution		Field Measurements/Component Compliance

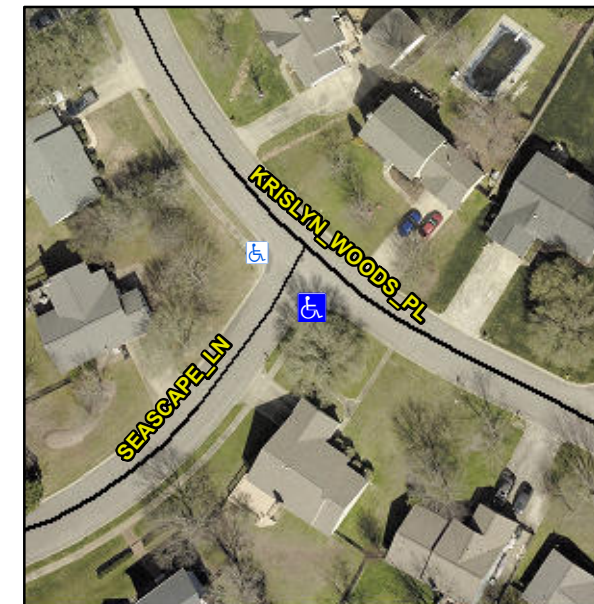
Compliance	Description	Data	Compliance	Description	Data
N/A	Ramp Length (in)	66.5	N/A	Grade Break?	N/A
No	Ramp Width (in)	46.5	N/A	Grade Break Slope (%)	0.0
Yes	Ramp Slope (%)	0.0	N/A	Grade Break XSlope (%)	0.0
No	Ramp XSlope (%)	6.0			
N/A	Flare Type LT	N/A	N/A	Flare Type RT	N/A
N/A	Flare Slope LT (%)	N/A	N/A	Flare Slope RT (%)	0.0
N/A	Flare Traversable LT?	N/A	N/A	Flare Traversable RT?	N/A
N/A	Landing Length (in)	0.0	N/A	DWS Provided?	N/A
N/A	Landing Width (in)	0.0	N/A	DWS Contrast?	N/A
N/A	Landing Slope (%)	0.0	N/A	DWS Length (in)	N/A
N/A	Landing X Slope (%)	0.0	N/A	DWS Full Width?	N/A
N/A	Landing Curb? (Y/N)	N/A	N/A	DWS Offset LT (in)	N/A
N/A	Shared Landing?	N/A	N/A	DWS Offset RT (in)	N/A
N/A	Gutter Ponding?	0.0	N/A	Gutter Slope (%)	N/A
N/A	Gutter Lip Ht (in)	0.0	N/A	Gutter X Slope (%)	N/A
N/A	Painted X Walk1?	No		Road Slope (%)	0.3
	X Walk 1 Direction	To W		Road X Slope (%)	0.0
	X Walk 1 Width (in)	N/A		Clear Space?	N/A

X Walk 1 Slope (%)	0.3	N/A	Clear Space to XWalk (in)	N/A
	X Walk 1 X Slope (%)	0.0	N/A	Storm Grate/Utility Hazard?	N/A
N/A	Ramp inside XWalk1?	N/A		Storm Grate/Utility Type	
N/A	Any Obstructions?	N/A			N/A
	Obstruction Type		Yes	Surface Condition? (G/P)	Good
			N/A	Curb Slope (%)	1.3

Possible Solutions:

Remove & Replace Entire Ramp.

R304.5.1, R304.5.3
