# Access Compliance Report

## Public Rights-of-Way

### (Curb Ramps)

| Intersection ID: 10041765 | Main Street: WILKINSON_BV | Cross Street: N/A | Location: S |

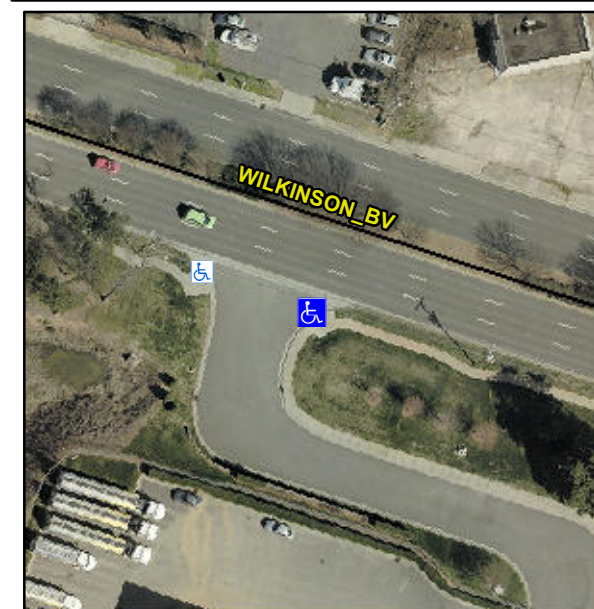
| ADA ID: C8156E5ABF6E | Ramp Type: PerpDiag | Initial Pass/Fail: Fail | Overall Compliance: No |
| Severity Score: 12.5 | | | |

**Not Found, R304.2.2**

| Compliance | Description | Data | Compliance | Description | Data |
|---|---|---|---|---|---|
| N/A | Ramp Length (in) | 60.0 | No | Ramp Slope (%) | 8.9 |

**Remove & Replace Curb Ramp With Two New Directional Ramps or Equivalent.**

Total Cost: \$ 3200.00
