Access Compliance Report

Public Rights-of-Way

(Curb Ramps)

Intersection ID: 3923	Main Street: BRIGHTLEAF_PL	Cross Street: COBBLE_GLEN_WY	Location:	E
ADA ID: C816534ADC94	Ramp Type: Directional1	Initial Pass/Fail: Fail	Overall Compliance: No	Severity Score: 8.75

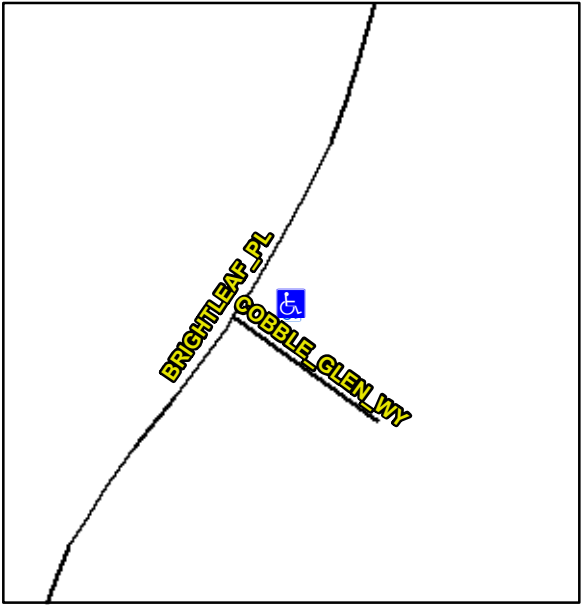
<p>Street 1 Name COBBLE GLEN WY</p> <p>Stop Condition-Street 1 StopSign</p> <p>Street 2 Name N/A</p> <p>Stop Condition-Street 2 N/A</p>	Possible Solutions:	Compliance	Description	Data	Compliance	Description	Data
	Remove & Replace Entire Ramp.	N/A	Ramp Length (in)	82.5	N/A	Grade Break?	N/A
		No	Ramp Width (in)	46.5	N/A	Grade Break Slope (%)	0.0
		Yes	Ramp Slope (%)	4.2	N/A	Grade Break XSlope (%)	0.0
		Yes	Ramp XSlope (%)	0.2			
		N/A	Flare Type LT	N/A	N/A	Flare Type RT	N/A
		N/A	Flare Slope LT (%)	N/A	N/A	Flare Slope RT (%)	0.0
	Surveyor Notes:	N/A	Flare Traversable LT?	N/A	N/A	Flare Traversable RT?	N/A
	N/A	N/A	Landing Length (in)	0.0	N/A	DWS Provided?	N/A
		N/A	Landing Width (in)	0.0	N/A	DWS Contrast?	N/A
		N/A	Landing Slope (%)	0.0	N/A	DWS Length (in)	N/A
		N/A	Landing X Slope (%)	0.0	N/A	DWS Full Width?	N/A
	PROW/ADA:	N/A	Landing Curb? (Y/N)	N/A	N/A	DWS Offset LT (in)	N/A

R304.5.1	N/A	Shared Landing?	N/A	N/A	DWS Offset RT (in)	N/A
		N/A	Gutter Ponding?	0.0	N/A	Gutter Slope (%)	N/A
		N/A	Gutter Lip Ht (in)	0.0	N/A	Gutter X Slope (%)	N/A
		N/A	Painted X Walk1?	No		Road Slope (%)	N/A
			X Walk 1 Direction	To SW		Road X Slope (%)	N/A
			X Walk 1 Width (in)	N/A		Clear Space?	N/A
			X Walk 1 Slope (%)	N/A	N/A	Clear Space to XWalk (in)	N/A
			X Walk 1 X Slope (%)	N/A	N/A	Storm Grate/Utility Hazard?	N/A
		N/A	Ramp inside XWalk1?	N/A		Storm Grate/Utility Type	
		N/A	Any Obstructions?	N/A			N/A
			Obstruction Type		Yes	Surface Condition? (G/P)	Good
					N/A	Curb Slope (%)	12.5
Total Cost:		\$	1600.00
