# Access Compliance Report

## Public Rights-of-Way

### (Curb Ramps)

Intersection ID: N/A	Main Street: DURANT_BV	Cross Street: KESSLER_DR	Location: E
ADA ID: C8224F3813B0	Ramp Type: PerpDiag	Initial Pass/Fail: Fail	Overall Compliance: No
Severity Score: 42.5			
Codes/Mitigation Info/Possible Solution		Field Measurements/Component Compliance

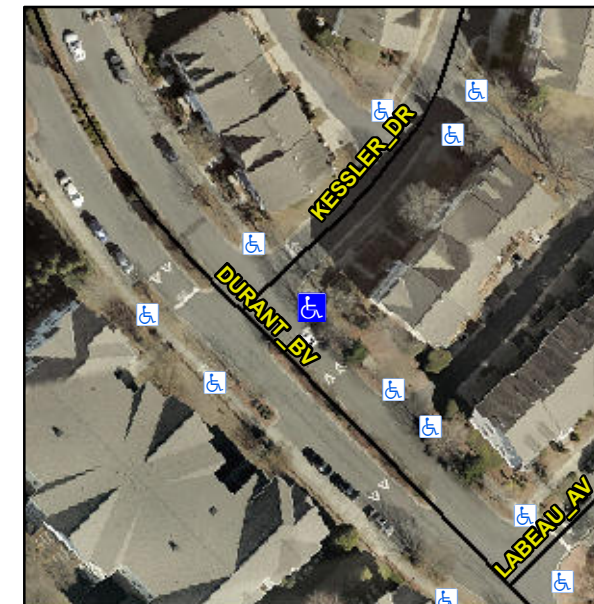
Compliance	Description	Data	Compliance	Description	Data
N/A	Ramp Length (in)	105.0	No	Ramp Slope (%)	8.6
No	Ramp Width (in)	35.0	No	Ramp XSlope (%)	6.3
N/A	Flare Type LT	N/A	N/A	Flare Type RT	N/A
N/A	Flare Slope LT (%)	N/A	N/A	Flare Slope RT (%)	N/A
N/A	Flare Traversable LT?	N/A	N/A	Flare Traversable RT?	N/A
N/A	Landing Length (in)	N/A	N/A	DWS Provided?	N/A
N/A	Landing Width (in)	N/A	N/A	DWS Contrast?	N/A
N/A	Landing Slope (%)	N/A	N/A	DWS Length (in)	N/A
N/A	Landing X Slope (%)	N/A	N/A	DWS Full Width?	N/A
N/A	Landing Curb? (Y/N)	N/A	N/A	DWS Offset (in)	N/A
N/A	Shared Landing?	N/A			
N/A	Gutter Ponding?	N/A	N/A	Gutter Slope (%)	N/A
N/A	Gutter Lip Ht (in)	N/A	N/A	Gutter X Slope (%)	N/A
N/A	Painted X Walk1?	No	N/A	Painted X Walk2?	No
	X Walk 1 Direction	To NW		X Walk 2 Direction	To W
N/A	X Walk 1 Width (in)	N/A	N/A	X Walk 2 Width (in)	N/A
	X Walk 1 Slope (%)	5.3		X Walk 2 Slope (%)	2.8
	X Walk 1 X Slope (%)	0.6		X Walk 2 X Slope (%)	5.4

N/A	Ramp inside XWalk1?	N/A	N/A	Ramp inside XWalk2?	N/A
	Road Slope (%)	5.0	N/A	Clear Space?	N/A
	Road X Slope (%)	3.1	N/A	Clear Space to XWalk (in)	N/A
N/A	Any Obstructions?	N/A	N/A	Storm Grate/Utility Hazard?	N/A
	Obstruction Type			Storm Grate/Utility Type	
		N/A			N/A
			Yes	Surface Condition? (G/P)	Good

Possible Solutions:

**Remove & Replace Curb Ramp With Two New Directional Ramps or Equivalent.**
