# Access Compliance Report

## Public Rights-of-Way

### (Curb Ramps)

| Intersection ID: 11877 | Main Street: BILLY_GRAHAM_PY | Cross Street: N/A | Location: SW |

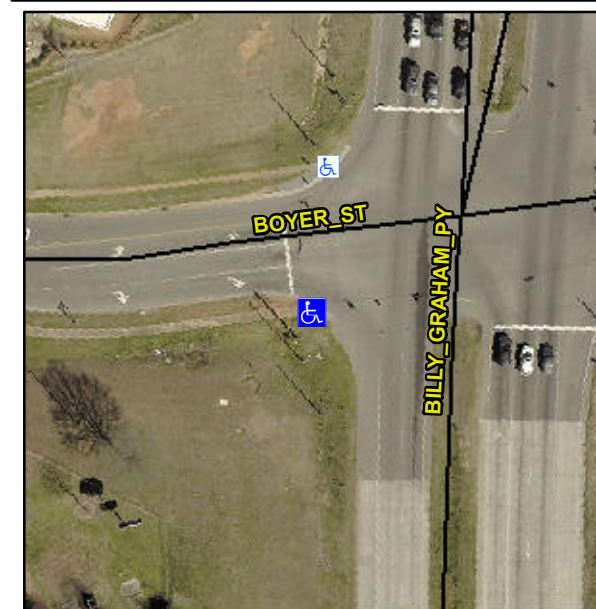
| ADA ID: C824303AF95C | Ramp Type: Perp | Initial Pass/Fail: Fail | Overall Compliance: No |
| Severity Score: 13.75 | | | |

**Not Found, R304.2.2, R304.5.3**

| Compliance | Description | Data | Compliance | Description | Data |
|---|---|---|---|---|---|
| N/A | Ramp Length (in) | 64.0 | No | Ramp Slope (%) | 10.4 |
| Yes | Ramp Width (in) | 48.0 | No | Ramp XSlope (%) | 4.1 |

**Remove & Replace Entire Ramp.**
