# Access Compliance Report

## Public Rights-of-Way

### (Curb Ramps)

| Intersection ID: 12632 | Main Street: SEIGLE_AV | Cross Street: SKYLINE_VIEW_WY | Location: | N |

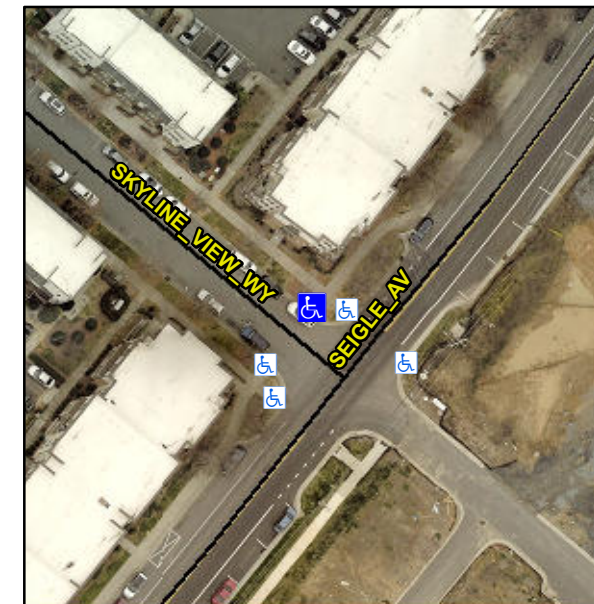
| ADA ID: C82C832904FA | Ramp Type: BlendTrans1 | Initial Pass/Fail: Fail | Overall Compliance: No | Severity Score: 1.25 |

**Not Found, R304.5.3**

**Remove & Replace Curb Ramp With Two New Directional Ramps or Equivalent.**

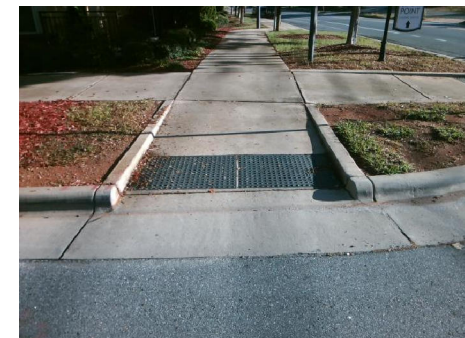
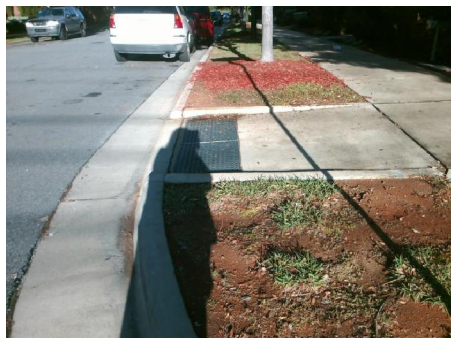
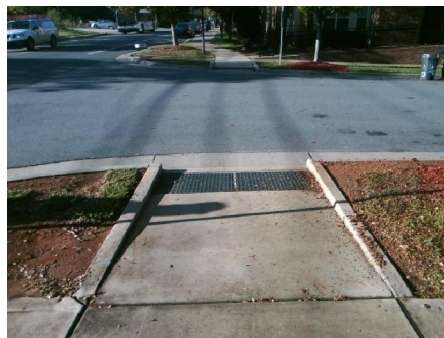
| Compliance | Description | Data | Compliance | Description | Data |
|---|---|---|---|---|---|
| Yes | Ramp Width (in) | 71.5 | No | BlendTrans XSlope (%) | 2.6 |
| | | | No | Curb Slope (%) | 14.3 |
