Access Compliance Report

Public Rights-of-Way

(Curb Ramps)

Intersection ID: 18385	Main Street: MONTFORD_DR	Cross Street: PARK_RD	Location: NW
ADA ID: C82D760D67F5	Ramp Type: Directional1	Initial Pass/Fail: Fail	Overall Compliance: No
Severity Score: 25			
Codes/Mitigation Info/Possible Solution		Field Measurements/Component Compliance

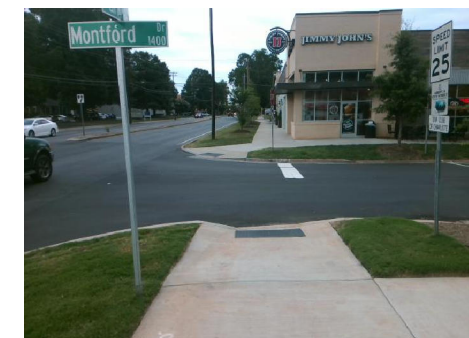
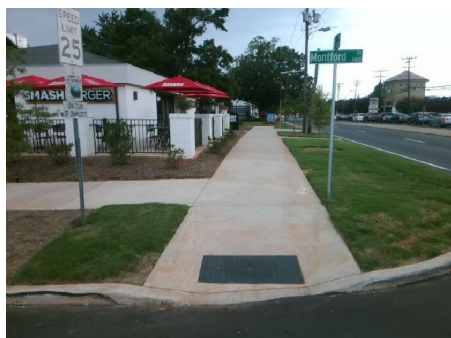
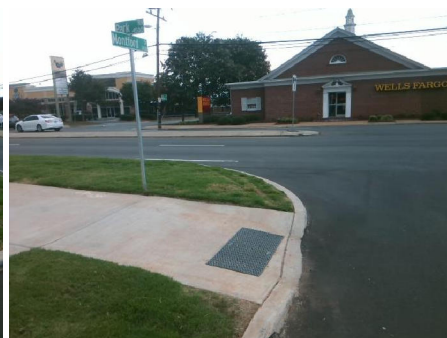
R304.2.2

Compliance	Description	Data	Compliance	Description	Data
N/A	Ramp Length (in)	102.0	N/A	Grade Break?	N/A
Yes	Ramp Width (in)	48.0	N/A	Grade Break Slope (%)	0.0
No	Ramp Slope (%)	12.9	N/A	Grade Break XSlope (%)	0.0
Yes	Ramp XSlope (%)	1.8			
N/A	Flare Type LT	N/A	N/A	Flare Type RT	N/A
N/A	Flare Slope LT (%)	N/A	N/A	Flare Slope RT (%)	0.0
N/A	Flare Traversable LT?	N/A	N/A	Flare Traversable RT?	N/A
N/A	Landing Length (in)	0.0	N/A	DWS Provided?	N/A
N/A	Landing Width (in)	0.0	N/A	DWS Contrast?	N/A
N/A	Landing Slope (%)	0.0	N/A	DWS Length (in)	N/A
N/A	Landing X Slope (%)	0.0	N/A	DWS Full Width?	N/A
N/A	Landing Curb? (Y/N)	N/A	N/A	DWS Offset LT (in)	N/A
N/A	Shared Landing?	N/A	N/A	DWS Offset RT (in)	N/A
N/A	Gutter Ponding?	0.0	N/A	Gutter Slope (%)	N/A
N/A	Gutter Lip Ht (in)	0.0	N/A	Gutter X Slope (%)	N/A
N/A	Painted X Walk1?	No		Road Slope (%)	4.4
	X Walk 1 Direction	To SE		Road X Slope (%)	2.0
	X Walk 1 Width (in)	N/A		Clear Space?	N/A

X Walk 1 Slope (%)	4.4	N/A	Clear Space to XWalk (in)	N/A
	X Walk 1 X Slope (%)	2.0	N/A	Storm Grate/Utility Hazard?	N/A
N/A	Ramp inside XWalk1?	N/A		Storm Grate/Utility Type	
N/A	Any Obstructions?	N/A			N/A
	Obstruction Type		Yes	Surface Condition? (G/P)	Good
			N/A	Curb Slope (%)	7.6

Remove & Replace Entire Ramp.
