# Access Compliance Report

## Public Rights-of-Way

| Intersection ID: 27468 | Main Street: BALLANTYNE COMMONS PY | Cross Street: JOHN J DELANEY DR | Location: NW |
| ADA ID: C833C2F6567D | Ramp Type: Perp | Initial Pass/Fail: Fail | Overall Compliance: No |

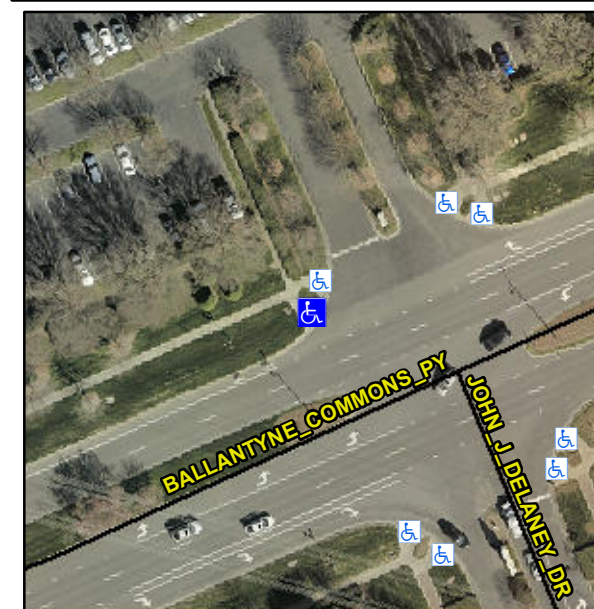
| Severity Score: 12.5 | | | |

**Not Found, R304.5.3**

| Compliance | Description | Data | Compliance | Description | Data |
|---|---|---|---|---|---|
| Yes | Ramp Width (in) | 48.0 | No | Ramp XSlope (%) | 5.1 |

**Remove & Replace Entire Ramp.**

Total Cost: \$ 1850.00
